Canadian
Wood
Council

Wood-Frame Construction

Meeting the Challenges of Earthquakes

Building Performance Bulletin

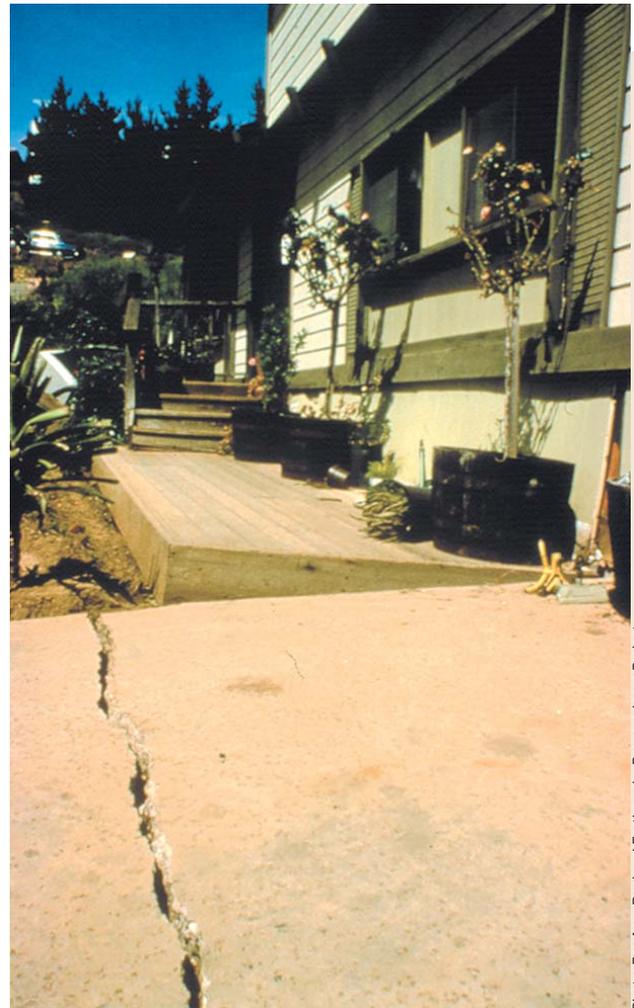
Exterior view of a wood-frame house illustrating damage caused by ground failure. Note cracks in the pavement at the front of the house.

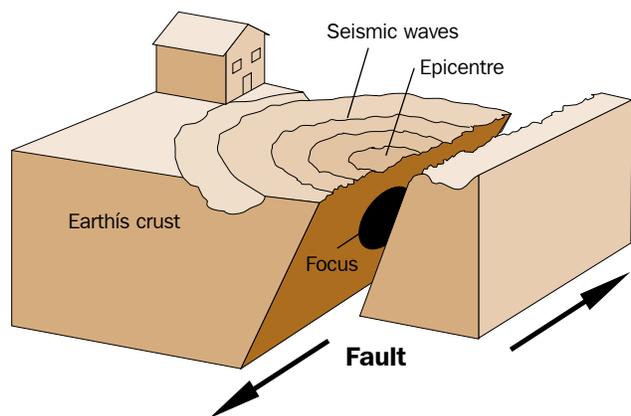
Figure 1: Earthquake Basics

Most earthquakes originate from the regions at the junctions of the plates that make up the earth's crust. These plates are constantly shifting, creating stresses and distortions. Where the stress is greater than the strength of the crust, there will be a sudden slippage that releases energy and causes seismic waves on the earth's surface. The place where the energy is released is called the focus of the earthquake, and the point on the earth's surface directly above the focus is called the epicentre. (Figure 1)

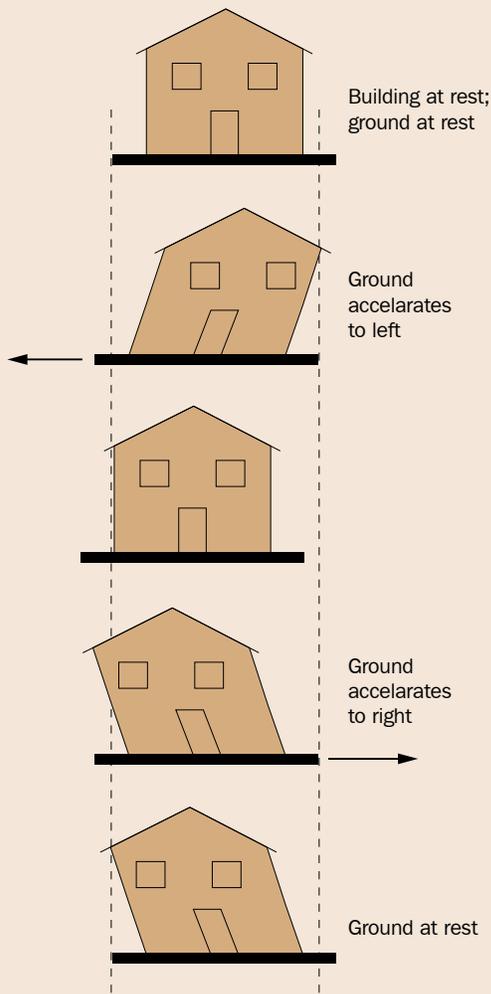
Figure 2: When the Ground Moves

the building in their original positions. (Figure 2) If ground displacement were to occur very gradually, the building would ride along easily, however, earthquakes involve rapidly accelerating ground forces. The forces generated in the earthquake depend on the weight of a building and how quickly the ground accelerates. Since inertial forces are greater when objects are heavier, earthquake forces are higher in heavier building. Likewise, higher ground accelerations create more stress in the structure. Earthquakes will affect buildings differently depending on the characteristics of the ground motion and characteristics of the building structure.

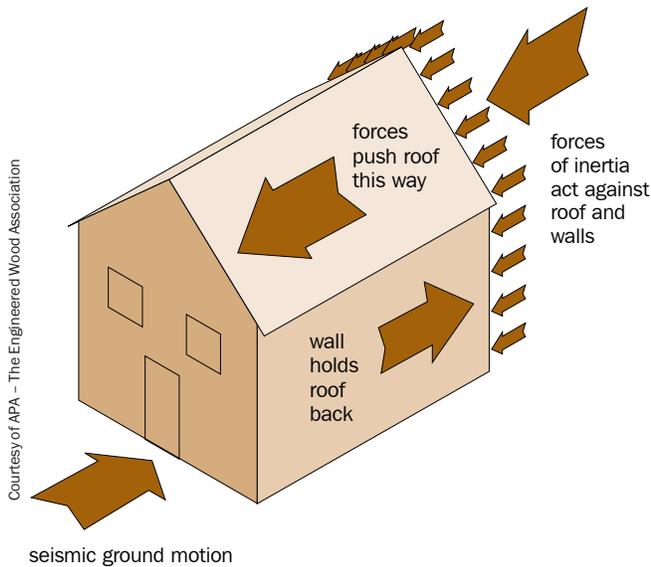
Figure 3: Seismic Forces on a Building

The inertial forces generated by the ground movement of the earthquake, concentrate lateral forces in the roof and floors where the mass of the building is greatest. The forces in the roof and floors must be resisted by walls and the entire structure must be adequately connected to the foundation. (Figure 3) The following components of wood-frame construction are critical to the resistance of seismic forces:

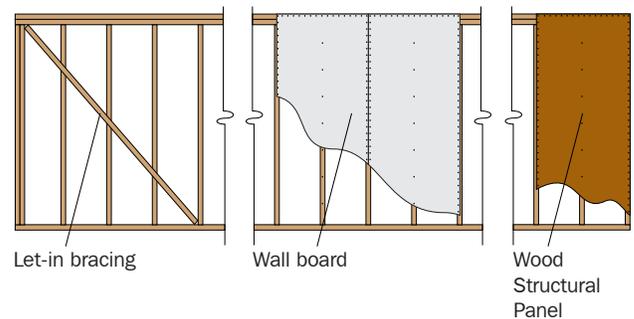
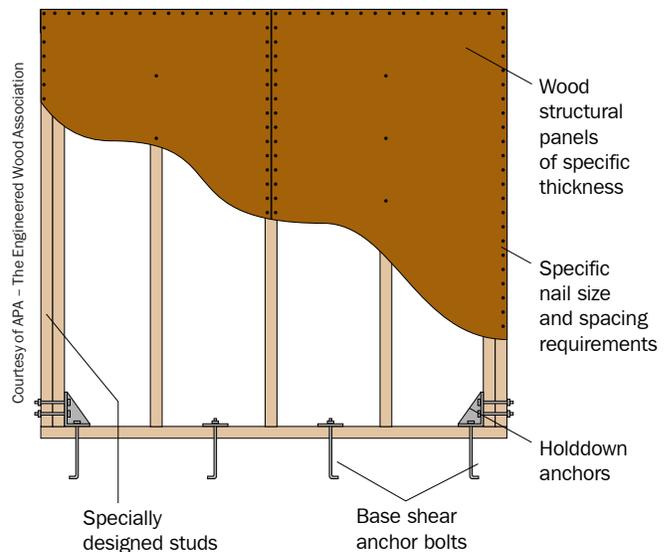
Figure 4: Shear Resisting Elements

Engineered design also requires adequate connections between all of the elements in the load path. Therefore, additional nails or special framing anchors are typically required to connect the diaphragms to the shearwalls. Special “hold-down” connections are used to hold down the corners of the shearwalls and additional anchor bolts are usually required to connect the shearwall to the foundation. (Figure 4)

Prescriptive Bracing

Engineered Shear Walls

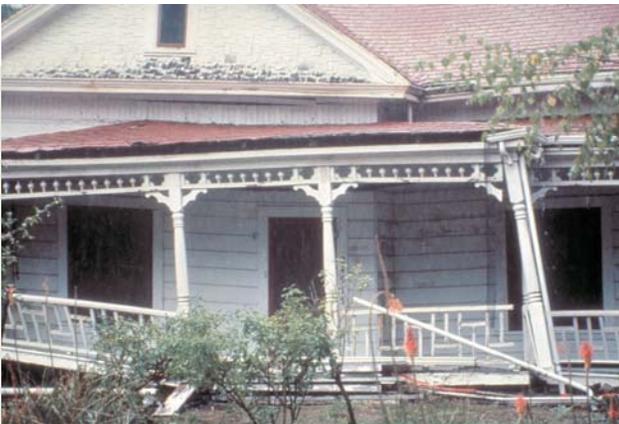
The majority of the wood-frame houses performed well, especially from the standpoint of life safety. Damage in older wood-frame houses in the San Fernando area ranged from superficial to partial collapse. Serious damage included houses sliding from foundations, collapse of “cripple walls” in crawl spaces, collapse of add-ons such as porches and collapse of masonry chimneys. Newer two-storey apartment buildings with large ground-level openings were also severely affected. Typically, these apartments were constructed to allow parking at the ground level. Because one wall of the garage storey was open, these floors were “soft storeys.”⁶

The importance of providing strong walls and foundation connections was recognized in this earthquake and building codes were updated accordingly.

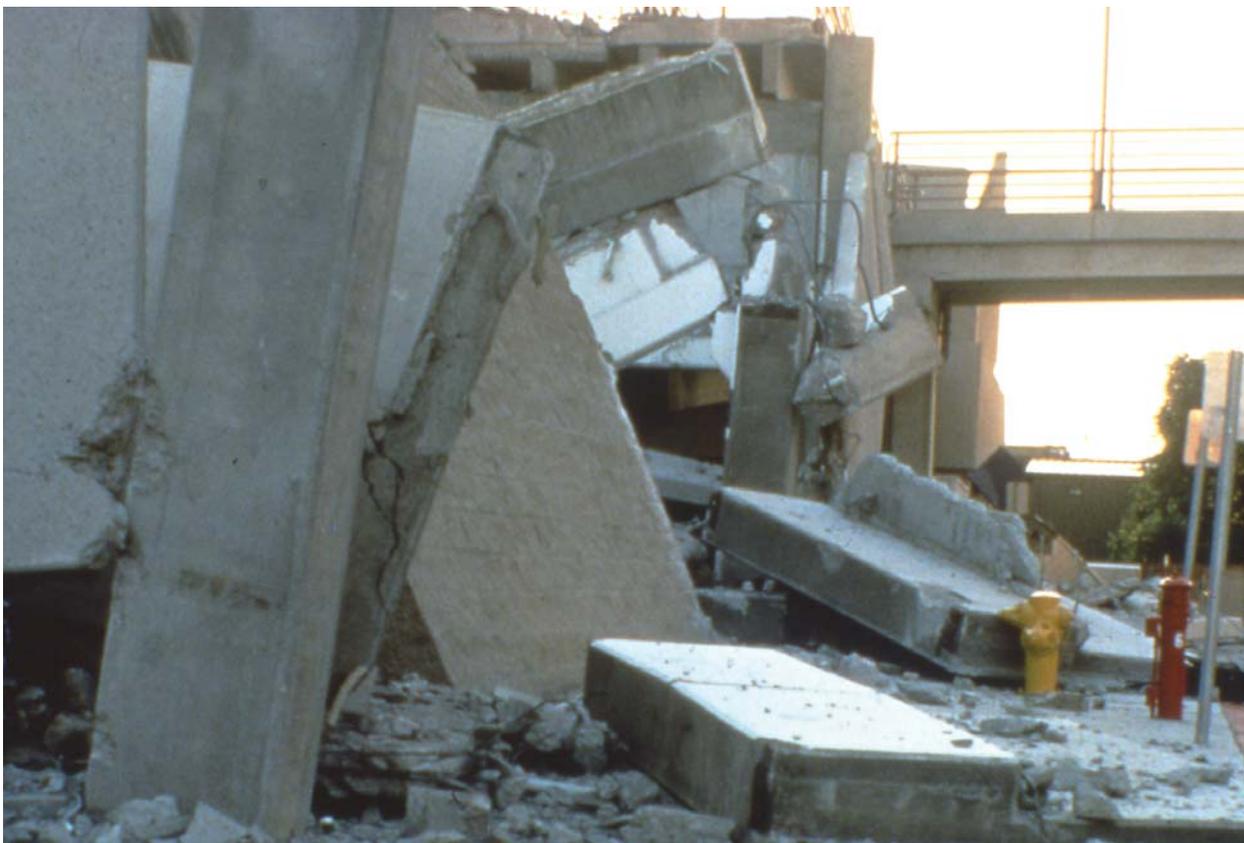
The second level of the concrete parking structure of the Northridge Fashion Center collapsed onto the lower level.

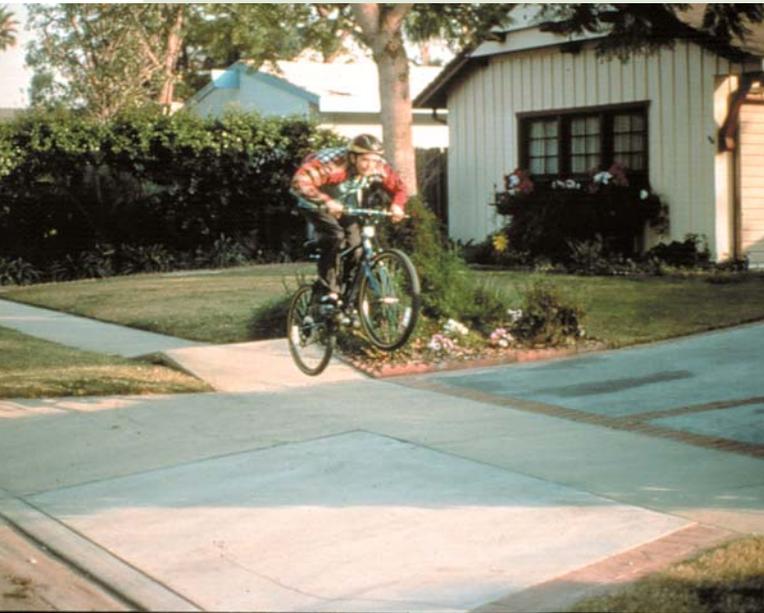
Overall wood-frame housing performed well in the Northridge earthquake. In front of this San Fernando Valley house, the sidewalk tented due to strong ground shaking although the house did not sustain visible damage.

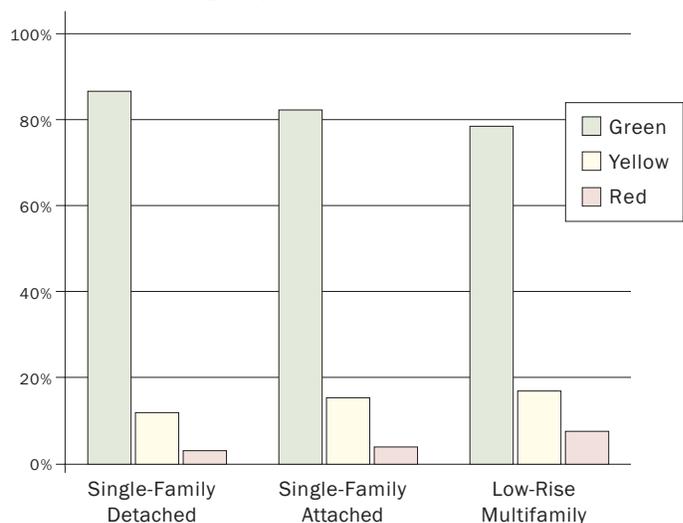
Figure 5: L.A. Department of Building and Safety Building Inspection Results

days after the Northridge Earthquake, many buildings in the Los Angeles area were inspected to determine if they were safe for occupancy. When there was concern about the safety of a building, an initial inspection was carried out and the building was tagged either “Red” for hazardous, “Yellow” for buildings that posed a threat to life, but not so much that an occupant could not re-enter to remove possessions and “Green” for buildings that did not pose a life-safety hazard to the occupants. After 4 days, almost 50,000 residential buildings had been inspected and over 85% of these were “Green Tagged” (Figure 5).

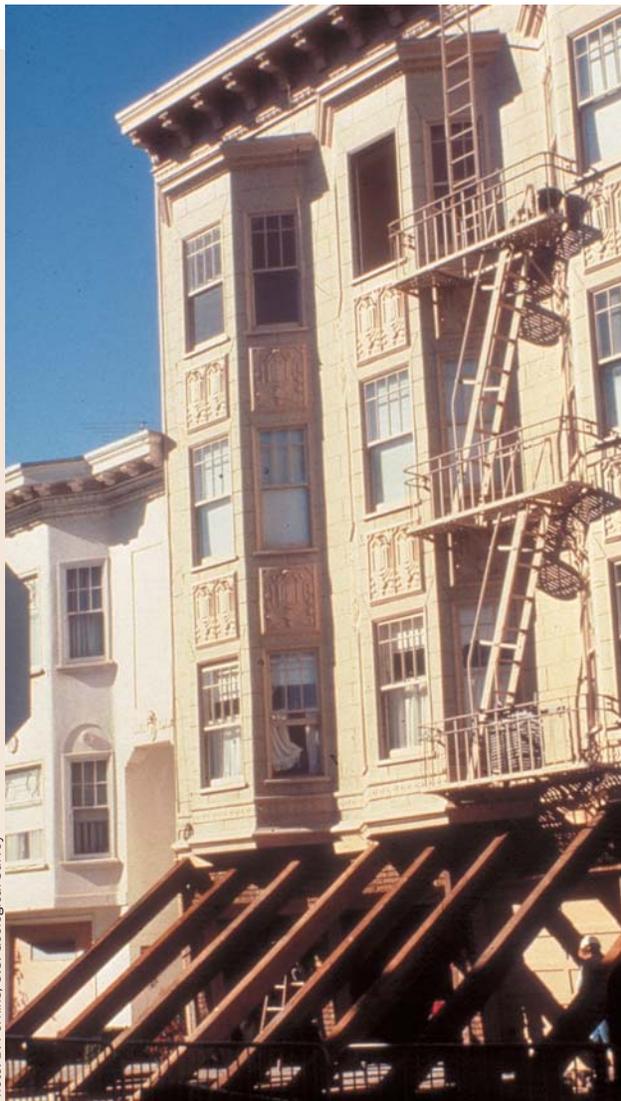
Shored building in the Marina District of San Francisco following the 1989 earthquake. Note the garage area on the first floor beneath the apartments that created a weak first storey.

Weak First Storey: Experience in past earthquakes has shown that weak and soft first storeys will make buildings susceptible to the effects of earthquakes. Providing adequately braced or sheathed walls is essential to ensure conventionally built wood-frame buildings can resist earthquakes. Large openings in the walls such as windows, doors and garage doors can leave too little wall area to provide adequate resistance to the lateral forces imposed by earthquakes. Unless these walls are adequately reinforced, lack of wall capacity leads to large distortions and eventual collapse. California experience has shown that multi-family apartments built with first storey garages are particularly vulnerable to earthquakes and building codes have recognized that buildings with soft storeys have to be carefully designed and detailed to resist earthquakes. Engineering solutions can be provided for new or existing structures that require additional wall reinforcement.

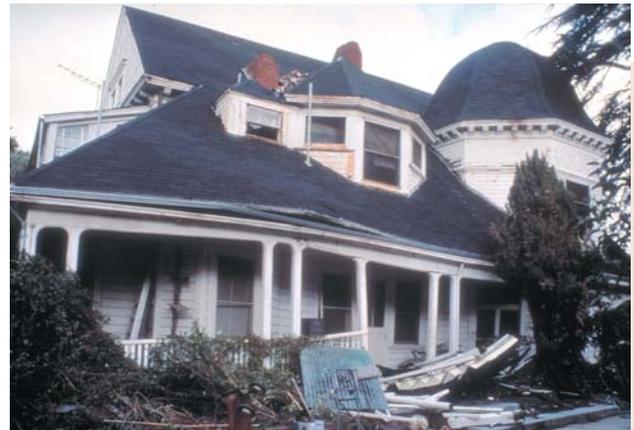
This turn-of-the-century wooden residence sustained major damage when it moved off its foundation in the 1989 Loma Prieta Earthquake.

Connections to Foundations: Anchor bolts are used to prevent a structure from moving off its foundation. Some old houses were built without using anchor bolts to connect the wood structure to the foundation. Experience has shown that these structures may slide off their foundations during an earthquake. These structures can be retrofitted by adding connections between the wood framing and foundation.

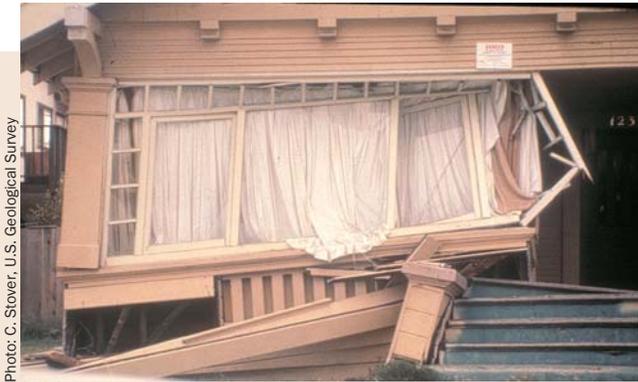
Failure of cripple wall in the Loma Prieta Earthquake.

Cripple Walls: Cripple walls, also known as knee walls or pony walls, are the short stud walls between the floors and foundations in some houses. Many older buildings that had unbraced cripple walls sustained structural damage during California earthquakes. Strengthening the walls using wood structural sheathing is an effective method of bracing cripple walls.

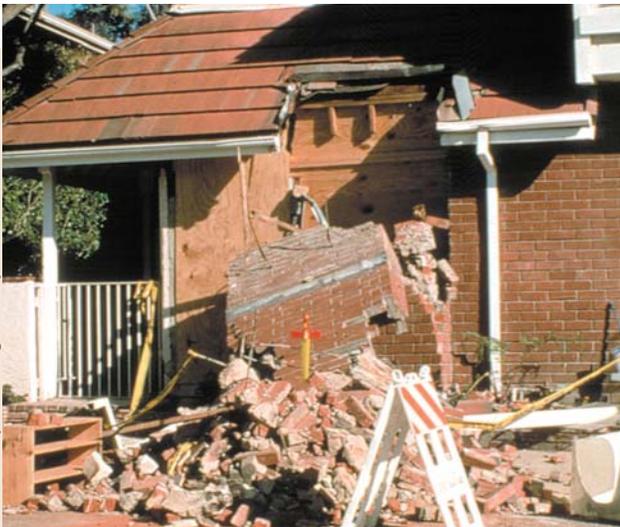
Chimney damage from the Northridge Earthquake.

Chimneys: Unreinforced masonry chimneys are particularly susceptible to earthquake damage. Failure of the chimneys can cause damage to the roof and walls of the structure below. Also, damaged chimneys may be dangerous in aftershocks following the initial earthquake. Bracing chimneys or using chimneys from lighter materials can help prevent damage in future earthquakes.

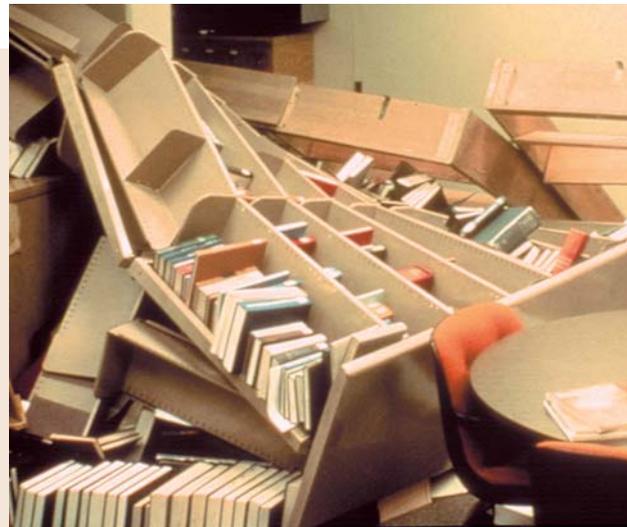
These overturned bookcases are typical of the damage that can occur during a strong earthquake.

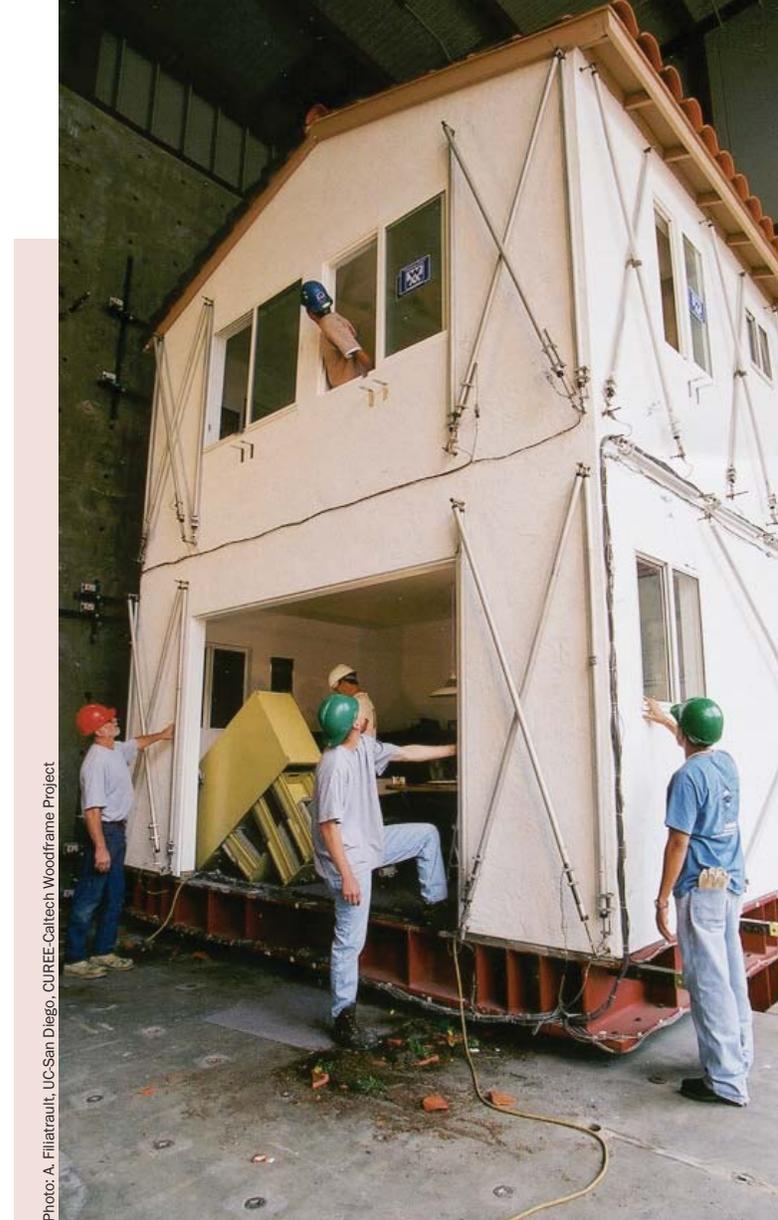
Full-scale shake tests involved the construction of a house on a special platform capable of simulating earthquake loads of different magnitudes.
