## **FIRESTOPPING TEST WITNESS REPORT**

**NORDIC STRUCTURES**

**September 26, 2016**

**GHL File NEW-4830.01**

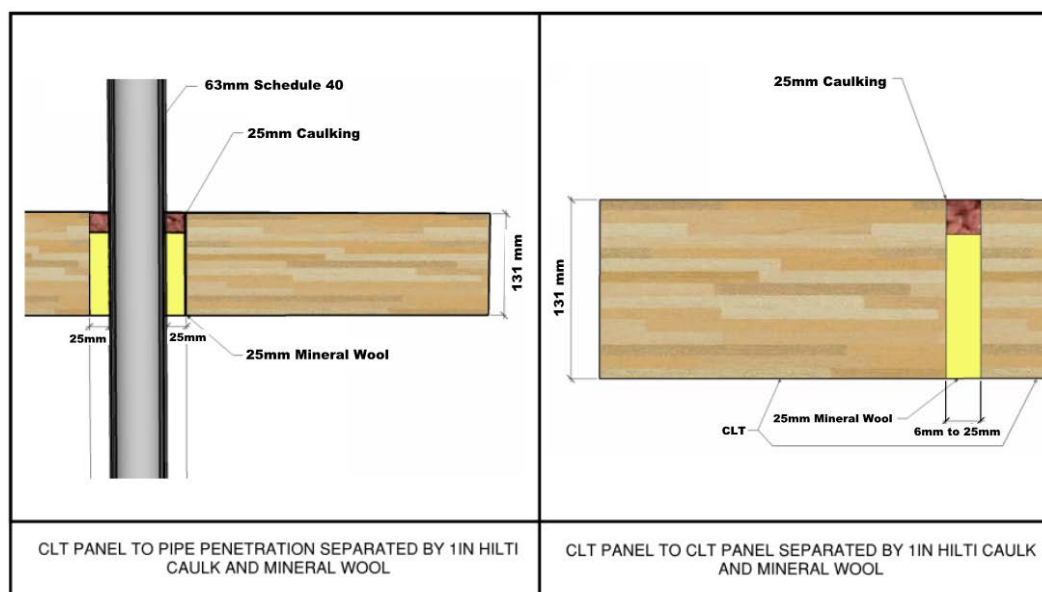
It is our opinion that the results from the tested firestopped penetrations can be applied to CLT floor joints. An example of applying the firestopping methods used for a tested penetration to butt-jointed CLT panels is shown in the diagrams below.

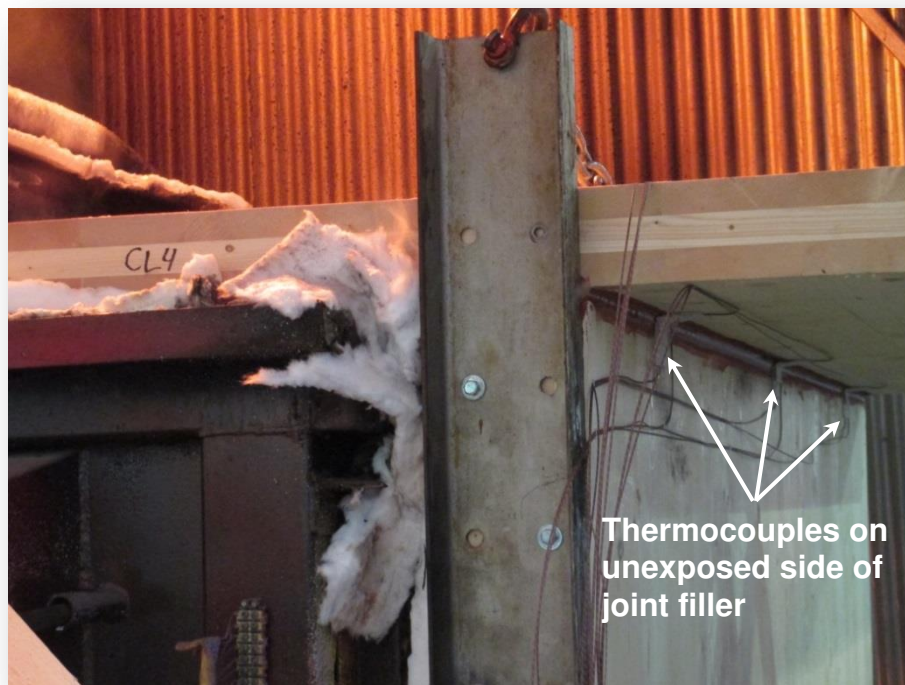
**Figure 4. Thermocouple locations for linear joint No. 3 (Wall-to-Floor)**

Unexposed surface thermocouples, as required by CAN/ULC S115, were mounted on the unexposed surface to determine eligibility for T-ratings. Details and pictures of the thermocouple locations can be found in the laboratory test report [9]. Figure 4 shows the thermocouple locations on the unexposed side, along the joint filler.

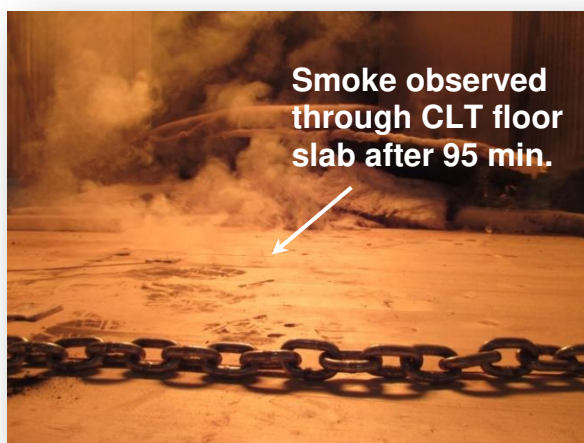
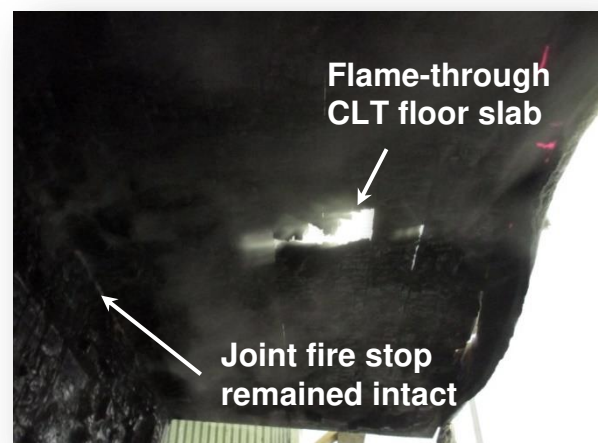
**Figure 11. Visual observations from test sample No.3**

At 89 minutes, sap was observed on the unexposed side of the 3-ply floor slab. At 95 minutes, smoke was observed leaking through the cracks of the 3-ply floor. The test was stopped at 96 min, at which point flaming through the floor slab was observed (Figure 11). However, no flames or smoke were observed through the joint fire stop or the 5-ply wall.

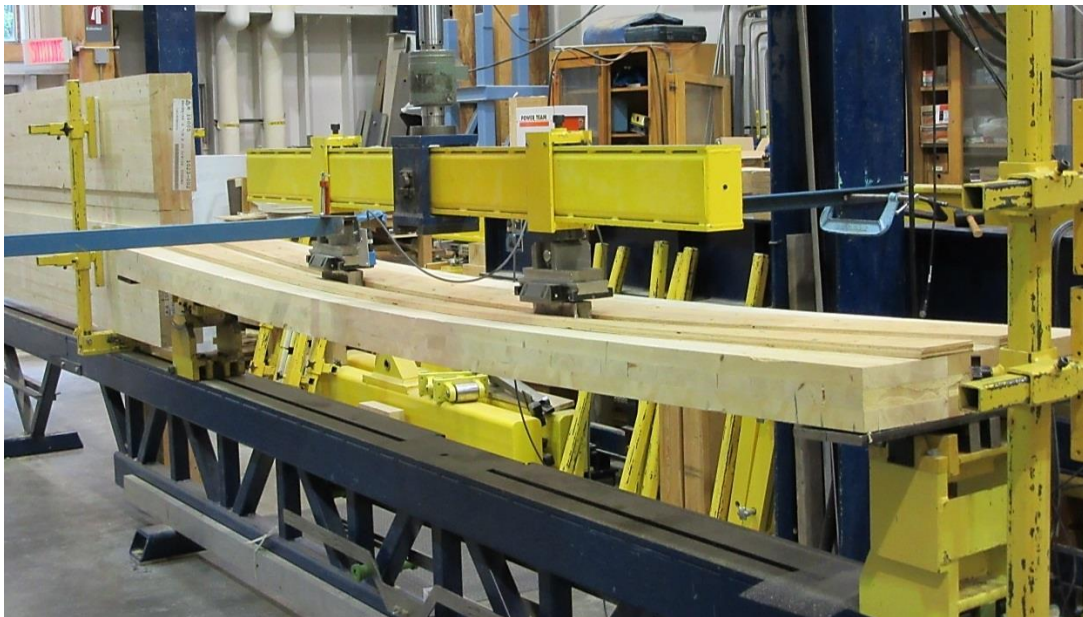
**Figure 4. CLT bending test under ambient conditions**

The test setup consisted of a smaller-scale version of the fire test setup, that is a simple span of 3.5 m (138 in.) subjected to a two-point loading conditions. Each loading point was placed at one-third of the span, replicating a similar stress distribution as that used in the fire tests. Three CLT panels were connected side-by-side using the same single surface plywood spline and self-tapping screws as those used in the fire tests, and where the loads were applied only on the middle panel (Figure 4).

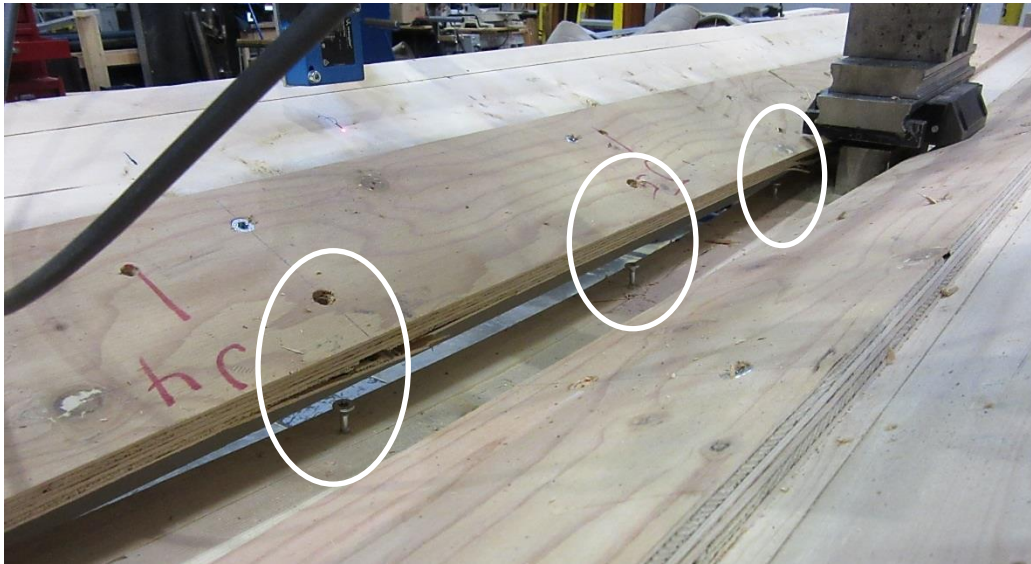
Figure 5. Head pull-through in CLT bending test under ambient conditions

Two specimens were evaluated and exhibit very similar behaviour. As expected, the fasteners were the weakest link; the failure mode was the screw heads pulling through the plywood splines (Figure 5). This confirmed that the loading conditions used in the fire-resistance tests need to be such that failure of the fasteners will not occur prematurely (i.e. pull-through should not occur, but withdrawal or lateral crushing could, or simply burn-through at the joints).
