# Durability of Wood Bridges

Paul Morris

Research Leader, Wood Protection Group, FPInnovations

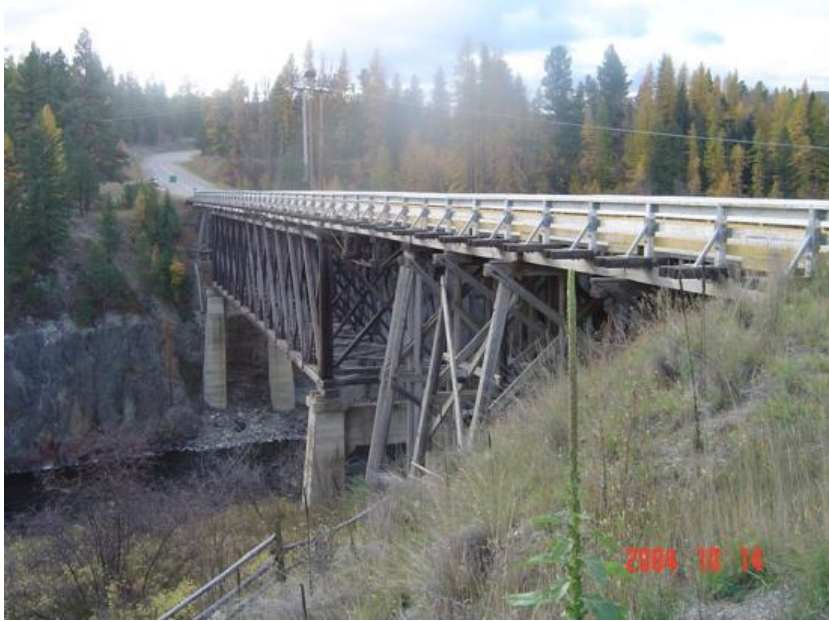
**Figure 1. St Mary's Wycliffe Bridge, near Cranbrook BC, built 1931. Photograph, prior to reconstruction, courtesy of the BC Ministry of Transportation and Infrastructure.**

There are numerous examples of old wood bridges still in service in North America (Figure 1). The oldest are traditional covered bridges (Figure 2), three of which are around 190 years old. In Southeast China, Fujian and Zhejiang provinces have numerous covered bridges that are almost 1000 years old (Figure 3). The fact that these bridges are still standing is a testament to the craftsmen that selected the materials, designed the structures, built them, monitored their condition and kept them maintained and repaired. They would have selected the most durable wood species available, likely Chestnut or cedars in North America, china fir (china cedar) in southeast China. They would have adzed off the thin perishable sapwood exposing only the naturally durable heartwood. The fact the covered bridges around today all look similar is because those were the tried and tested designs that worked. They clearly designed those bridges to shed water with a wood shingle roof, vertical siding projecting below the deck and structural elements sheltered from all but the worst wind-driven rain. Any rain that did not drip off the bottom of the vertical siding and wicked up the end grain would also dry out reasonably rapidly. Slow decay that did occur at the bottom of these boards was inconsequential because it was remote from connections to structural elements. Construction must have been meticulously performed by experienced craftsmen. Those craftsmen may well have been locals that would continue to monitor the bridge over its life and make any repairs necessary. Of course, not every component in those ancient bridges is original, particularly shingle roofs that typically last 20-30 years depending on climate. These bridges have all been repaired due to decay and in some cases dismantled and re-built over the years for various reasons (e.g., due to changes in traffic loads, arson, flooding, fire, hurricanes, etc.). The Wan'an Bridge in Fujian is known to have been built in 1090, refaced in 1708 and rebuilt in 1845, 1932 and 1953. The apparently increasing frequency of rebuilding may suggest a loss of knowledge and skills, but all repairs and reconstruction prior to 1845 may not have been recorded.

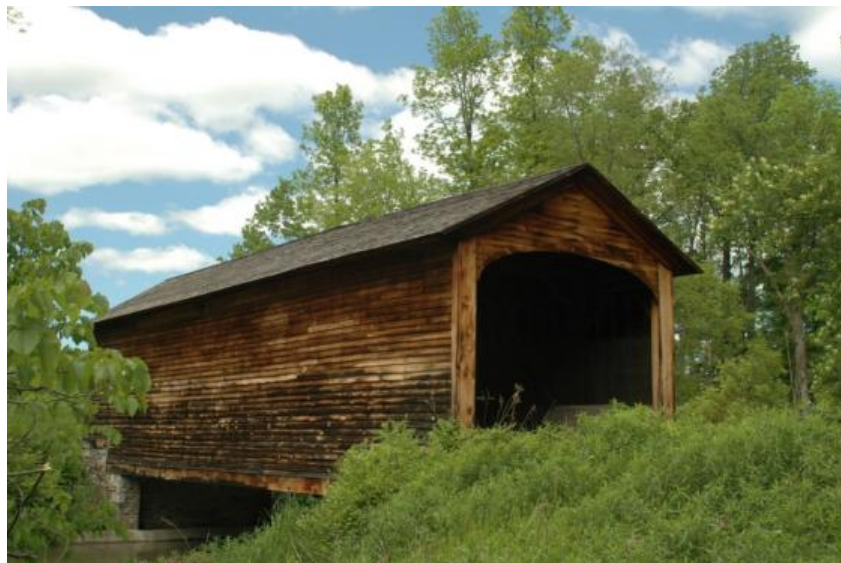
**Figure 2. Hyde Hall bridge, Springfield, New York, built in 1823. One of the oldest covered bridges in North America. Courtesy: Trish Kane/Theodore Burr Covered Bridge Resource Center, Oxford, NY.**

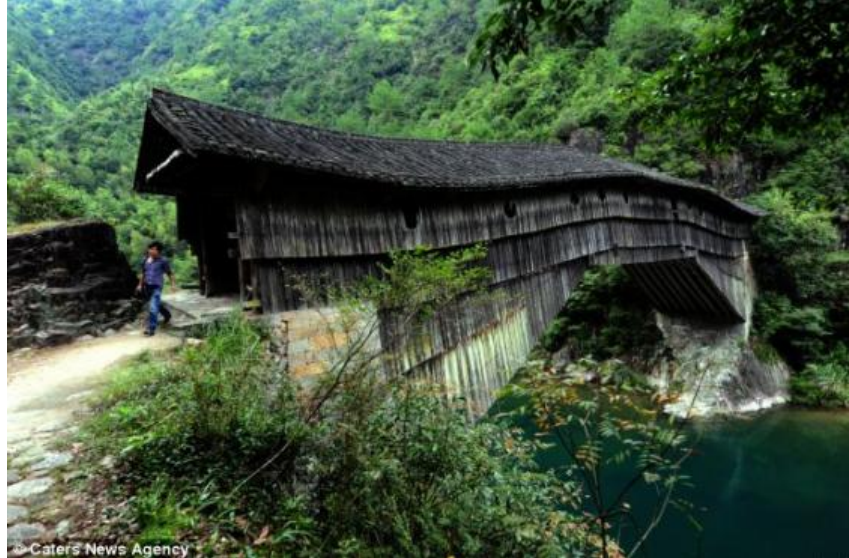
**Figure 3. Yangmeizhou bridge, in the Kengdi village of Shouning County, built during the Ming Dynasty (<http://www.dailymail.co.uk/news/article-2253793/The-1-000-year-old-wooden-bridges-modern-China-moving-Stunning-timber-structures-withstood-test-time.html>)**

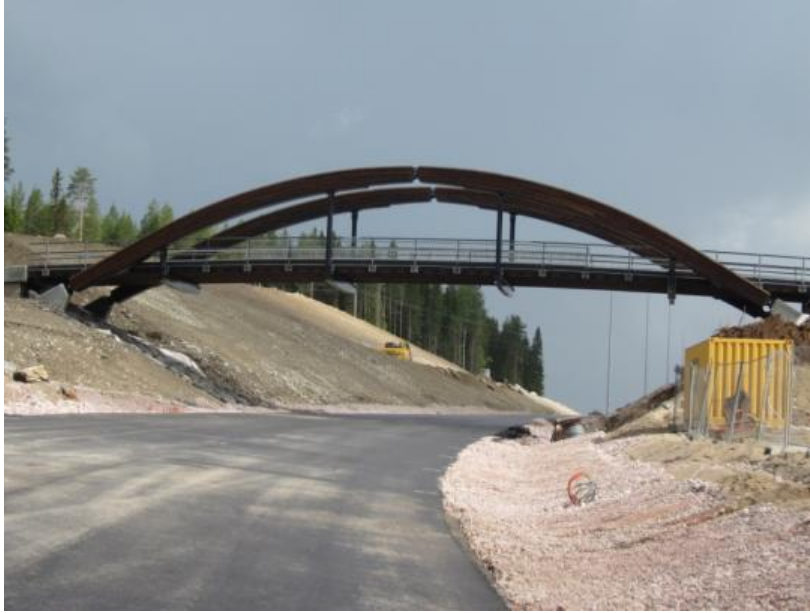
**Figure 4. Dual copper/creosote treated glulam in the Åset Bridge in Norway, built 2014.**

Due to the large dimensions of solid bridge timbers, the preferred preservatives are those that reduce splitting and checking. These include creosote, pentachlorophenol in oil, copper naphthenate in oil and ammoniacal copper zinc arsenate (ACZA is aqueous). Modern glue-laminated timbers are fabricated in a dry condition so oil-type preservatives should be used. One approach used in Norway is to pressure treat lamina with a waterborne copper-based preservative, fabricate into beams, cut to length and prepare all joints, pressure treat the bridge components with creosote (Figure 4). This works well because they use Scots pine which has wide treatable sapwood. For Canadian wood species which are predominantly heartwood, dual treatment with borates and oil-type preservatives should provide better protection since borates will penetrate heartwood and the oil-type preservative keeps away the moisture that would cause the borate to leach out. Dual borate/oil-type preservative treatment processes have been developed for solid timbers and are under development for glue-laminated beams. Chromated copper arsenate (CCA) can be used for timbers, but is preferred for smaller dimension bridge components, particularly those where incidental human contact is likely. The CSA O80 series of standards on wood preservation should be specified in Canada and the American Wood Protection Association standards should be specified in the USA. The preservative treatment of parallel strand lumber and laminated veneer lumber should be in accordance with AWP A U1 and T1, since there are no specifications for these materials in the CSA O80 series.

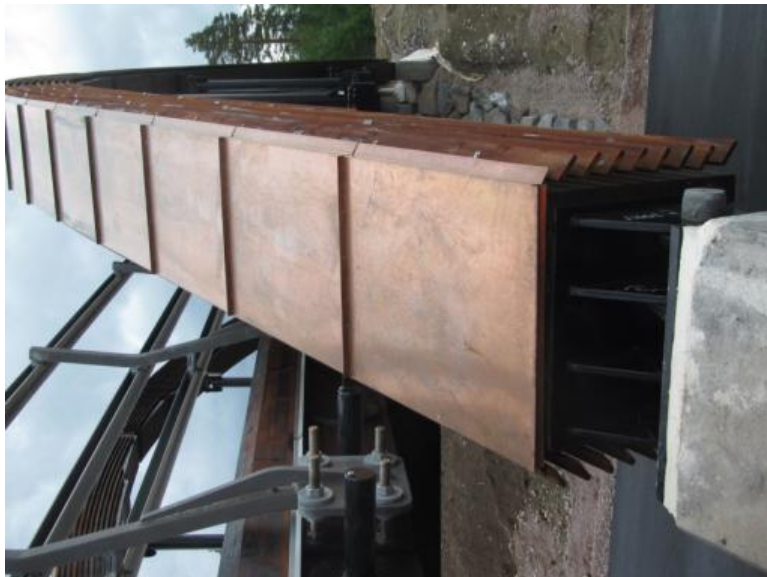
**Figure 5. Copper flashing, louvers and drainage promoting connection on Åset Bridge in Norway, built in 2014.**

- Use metal flashing to deflect rain from horizontal and sloped surfaces and any V joints (copper lasts longest). The upper surface of timbers tends to develop checks that trap water (Figure 5).
- Use naturally durable or preserved wood louvers or cladding to deflect rain from sides of beams.
- Avoid end grain of timber components bearing directly onto concrete that can be damp. Use durable damp-proof membrane or provide small gaps at all interfaces.
- Preserved wood bridge decks can be protected with a bituminous waterproofing layer and an asphalt wear surface requiring no expansion joint.
- A concrete bridge deck can provide considerable protection against precipitation but is not perfect (see comments above).

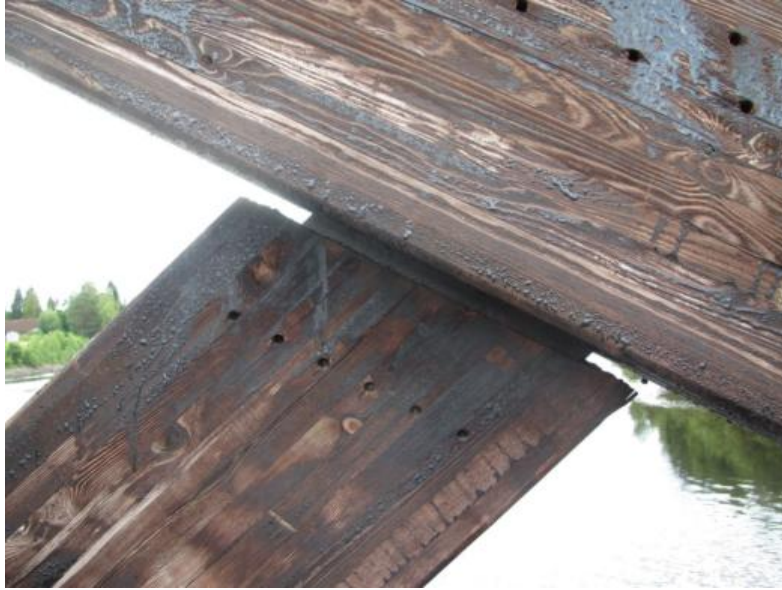
**Figure 6. Wood components spaced apart by metal connectors on the Flisa bridge in Norway.**

- Use wood-metal-plate-wood connections to space wood components apart at least 10mm (Figure 6).
- Support columns on metal fittings that permit water to drain from the wood surface.

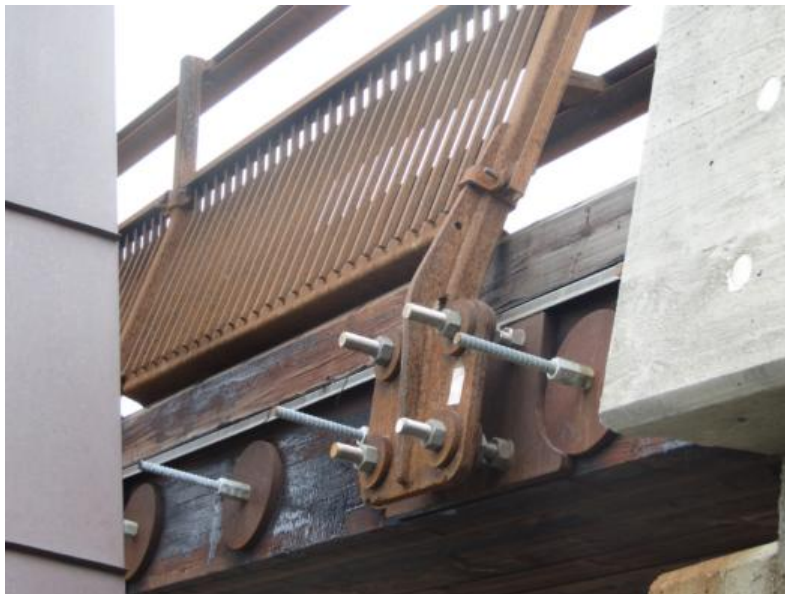
**Figure 7. Metal plate connectors not too large to prevent drying on Sletta Bridge in Norway.**

- Expose wood components to drying winds as much as possible.
- It is most important to permit drying from the end grain of wood components.
- Avoid large solid metal plate connectors on the sides or ends of wood components (Figure 7).
- Use flashing or waterproofing on no more than two sides of wood components.
- Smaller components dry faster than larger components.
