## ***Treated Millwork***

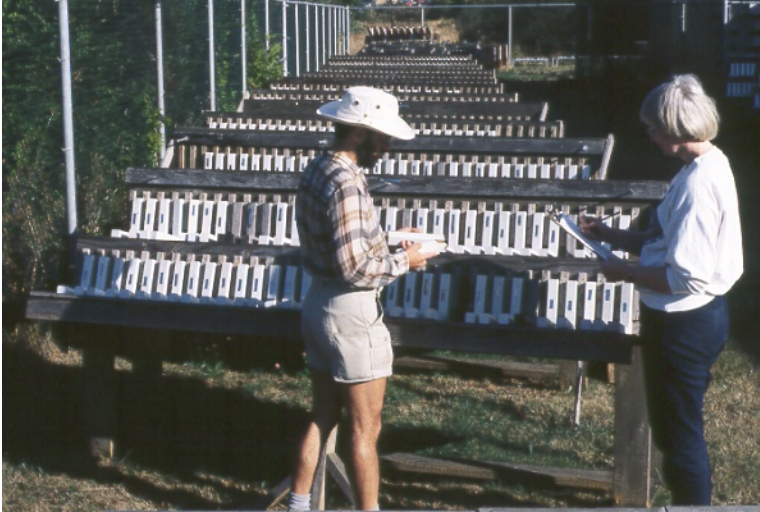
Millwork preservatives are evaluated using an accelerated test, which simulates the lower part of the opening light of a window. No protection from weather is provided, and an initial break in the paint film is deliberately applied. Millwork was once commonly treated with Pentachlorophenol but the registration for this use has been withdrawn.

**Test Method:** L-joint
