Seismic Design with Wood:

Solutions for British
Columbia Schools

A CASE STUDY

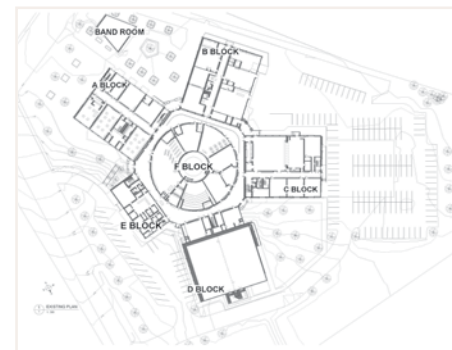
Figure 3.1: Site plan - existing

Located in Nanaimo on the east coast of Vancouver Island, Wellington Secondary School is a two-storey, 10,750 m² structure with a capacity of 900 students from Grades 8 to 12. The school was built in several phases from 1969 to 2000. The plan is unusual and, at the time of the seismic assessment, consisted of a circular central block (Block F) with a small open courtyard at its centre, from which five other blocks radiated. These outer blocks (Blocks A, B, C, D and E) contained the classrooms, shops, a gymnasium and administrative spaces (Figure 3.1).

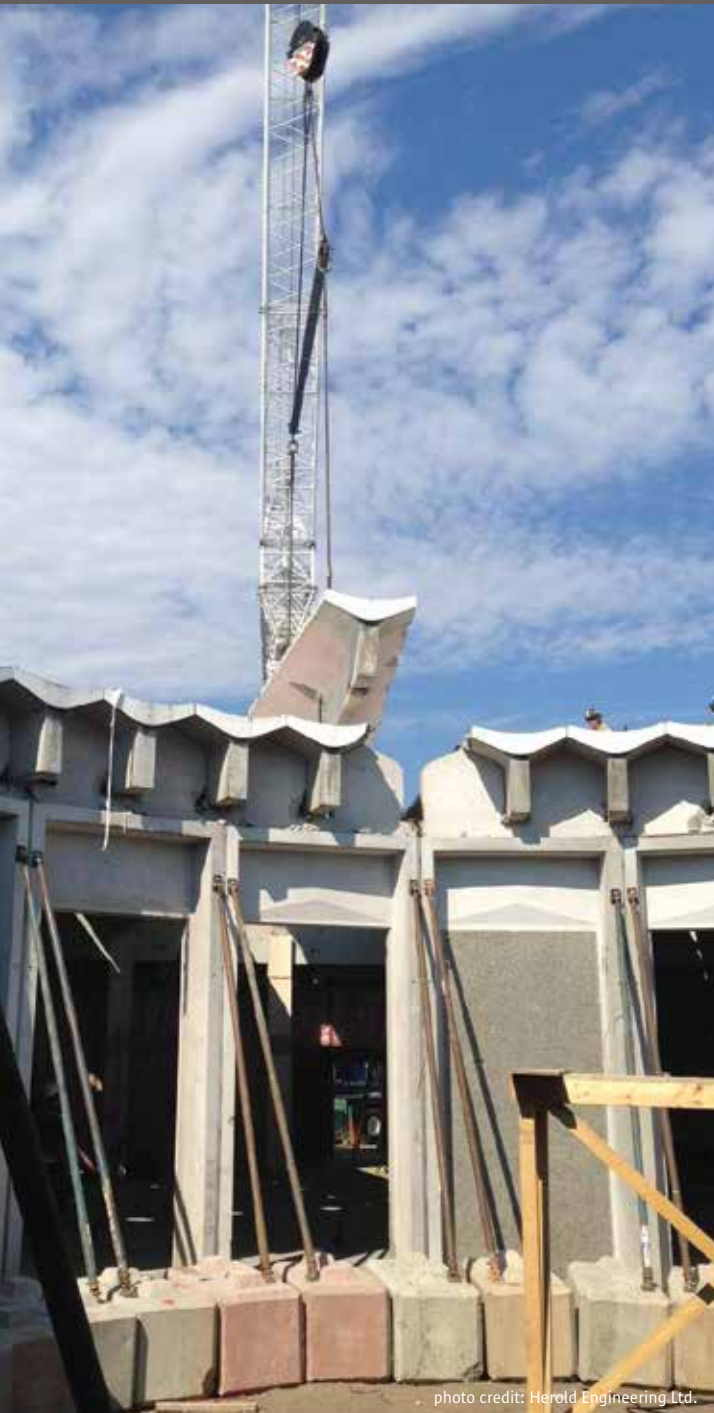
Figure 3.3: Wellington Secondary: dismantling of Block F

The original 1969 library structure (Block F) presented a considerable challenge to upgrade, and the analysis merits more detailed discussion. The roof structure consisted of radially arranged concrete T-beams resting on inner and outer concrete ring beams supported on concrete columns (Figure 3.3). These columns were supported in turn on concrete walls at basement level. The entire structure was heavy and, having been designed to a much less demanding seismic standard, did not have the required ductile connections between the elements nor adequate lateral restraint in the radial direction.

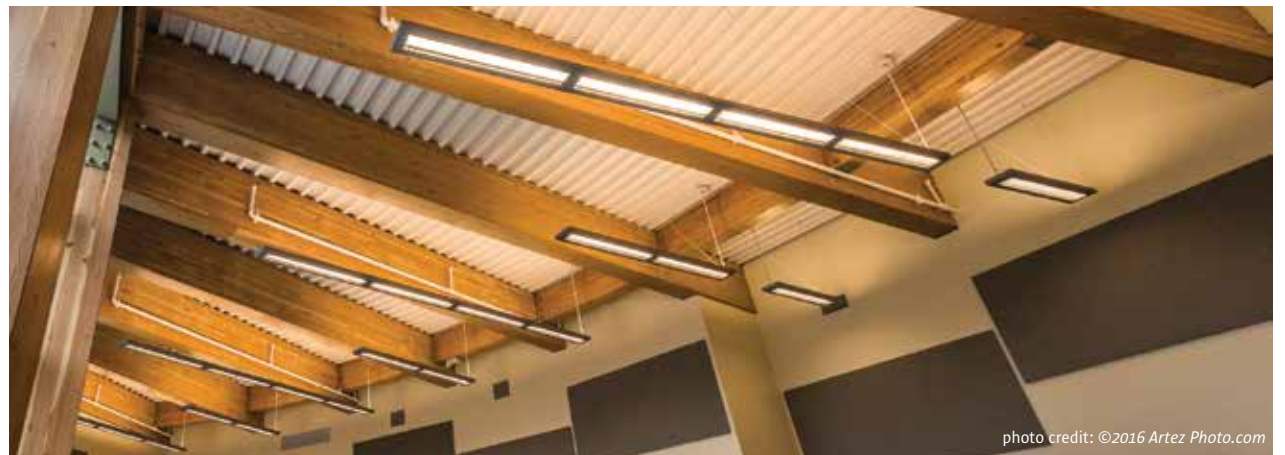
Figure 3.4: Wellington Secondary: New structural members in Block F

Wood was chosen for this new structure for reasons of economy, speed of construction and aesthetics (Figure 3.4). The wood solution met the constraints of a fast-track schedule and a tight budget, and at the same time introduced a warm look to the core of the school.

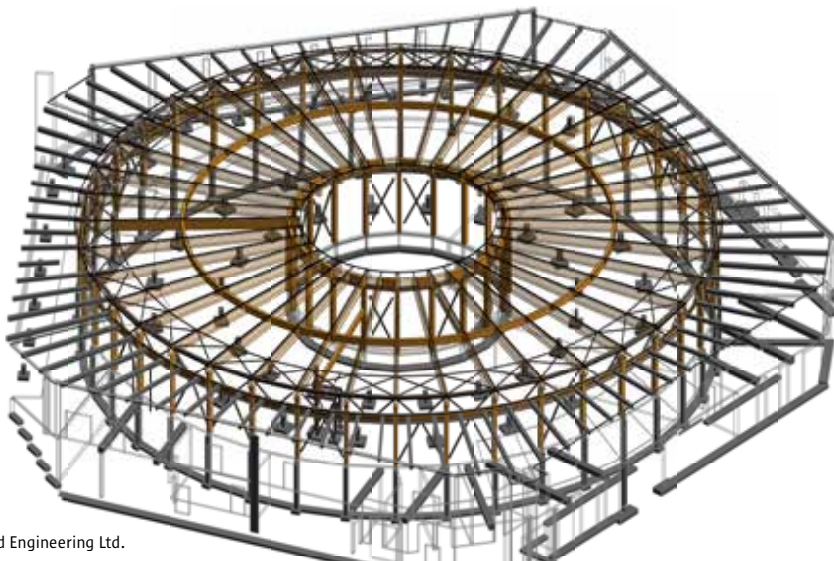
Figure 3.5: Wellington Secondary: 3-D model of wood structure for new Block F

The structural engineers developed a retrofit system for Block F that made use of the existing foundations and replicated the geometry of the original (Figure 3.5). In plan, Block F is divided into two distinct but connected components. The 'main street' surrounds the central courtyard and forms a circle with an inner and outer ring of columns supporting a sloping roof. The inner ring of columns delineates the exterior glazed wall that encircles the courtyard, while the outer ring forms a colonnade that separates the main street from the rest of the school.

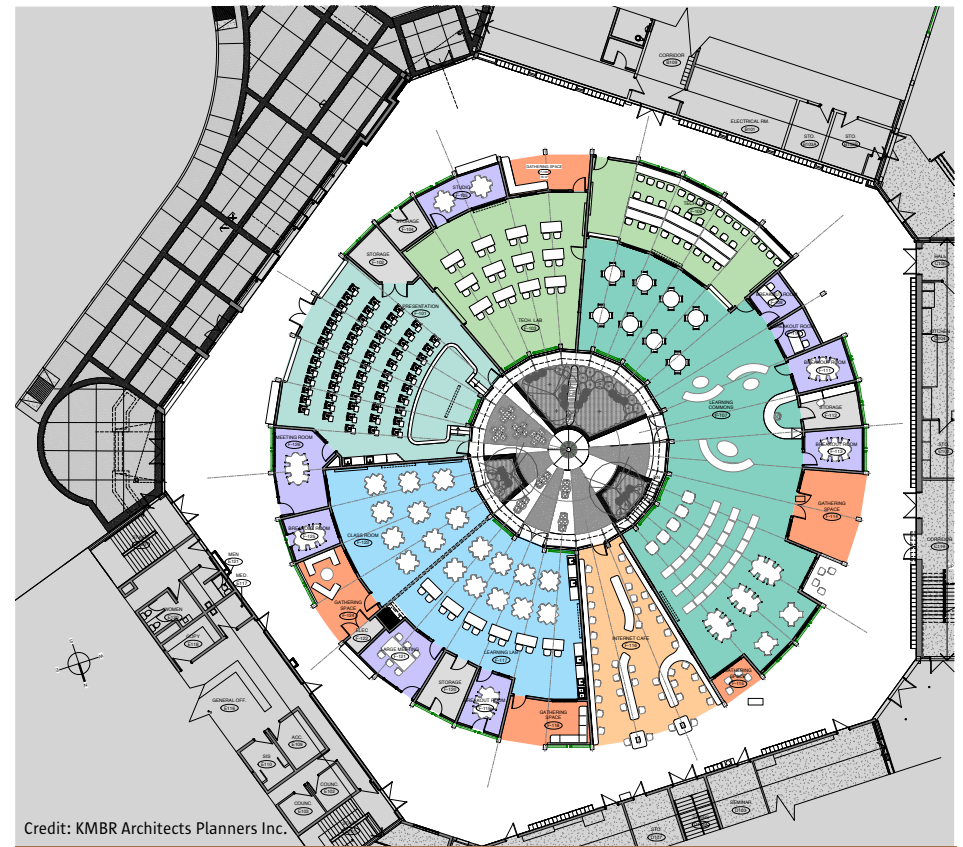
Figure 3.6: Wellington Secondary: Floor plan of new Block F

The main street is circular in plan, and the surrounding school is in the form of a pentagon, leaving an irregularly shaped zone between them (Figure 3.6). This zone was covered by an existing flat roof that was originally framed with solid timbers. The longest of these members had to be reinforced with laminated veneer lumber (LVL) beams so the roof could perform as an effective diaphragm between Block F and the surrounding blocks. The engineers also added a second layer of plywood sheathing in order to meet load transfer and drift requirements.

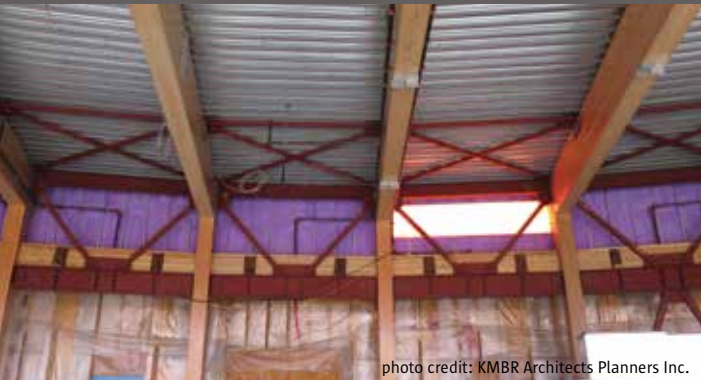
Figure 3.7: Wellington Secondary: Interior view of drag rings for load transfer

This upgraded roof connects to the outer ring of posts below the eave line of the central sloping roof. This results in a discontinuous section in which the roof diaphragms are not in the same plane, requiring that lateral loads be transferred into the vertical structure by a pair of ‘drag rings’ (Figures 3.7 and 3.8).

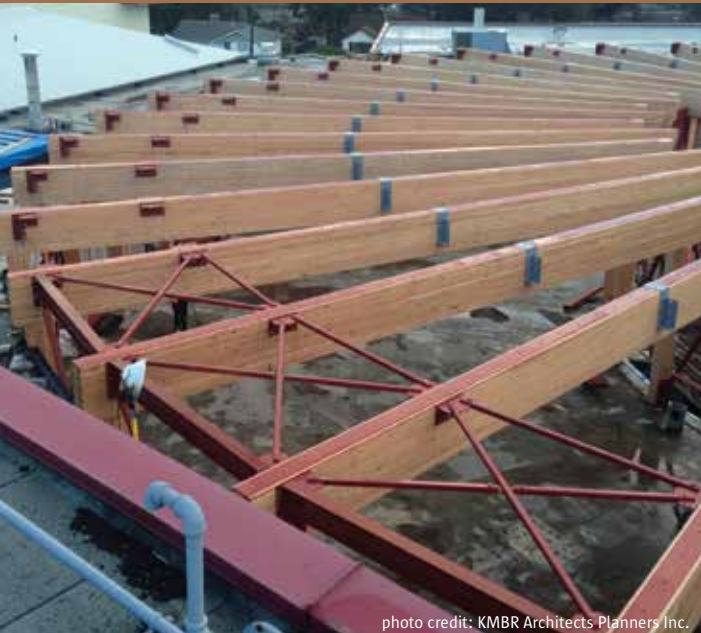
Figure 3.8: Wellington Secondary: Roof top view of drag rings for load transfer

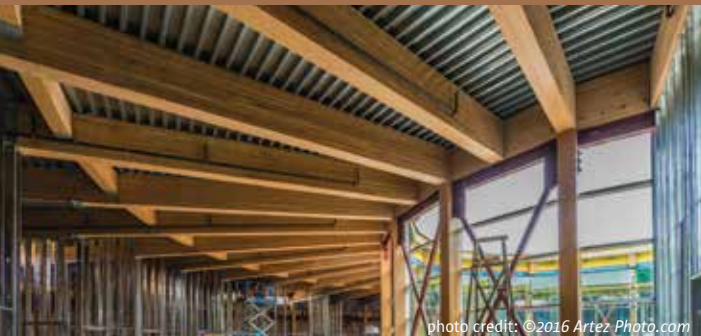
Figure 3.9: Wellington Secondary: Radial post-and-beam structure of Block F

The outer ring of columns consists of 265mm x 380mm glulam posts, while those in the inner ring are 265mm x 342mm. The glulam beams that span between the two sets of posts are 265mm x 760mm deep (Figure 3.9).

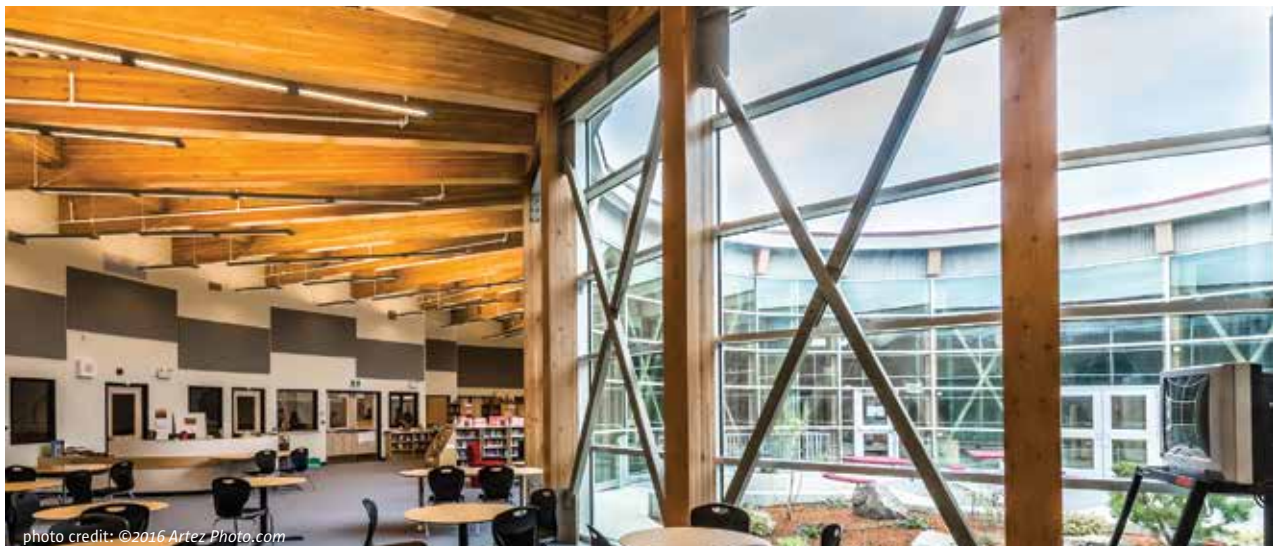
Figure 3.10: Wellington Secondary: Cross-bracing around the perimeter of the courtyard provides lateral stability

In the vertical plane, lateral resistance is provided by a series of 16 steel cross-braced frames that tie into adjacent pairs of glulam columns in the outer ring. Because these braces form a circle in plan, they are able to resist lateral forces in whatever direction they may be applied (Figure 3.10). Architecturally, this solution eliminates the need for solid shear walls, enabling the core of the school to be transparent and the activities on one side of the courtyard to be seen from the other (Figures 3.11 and 3.12).

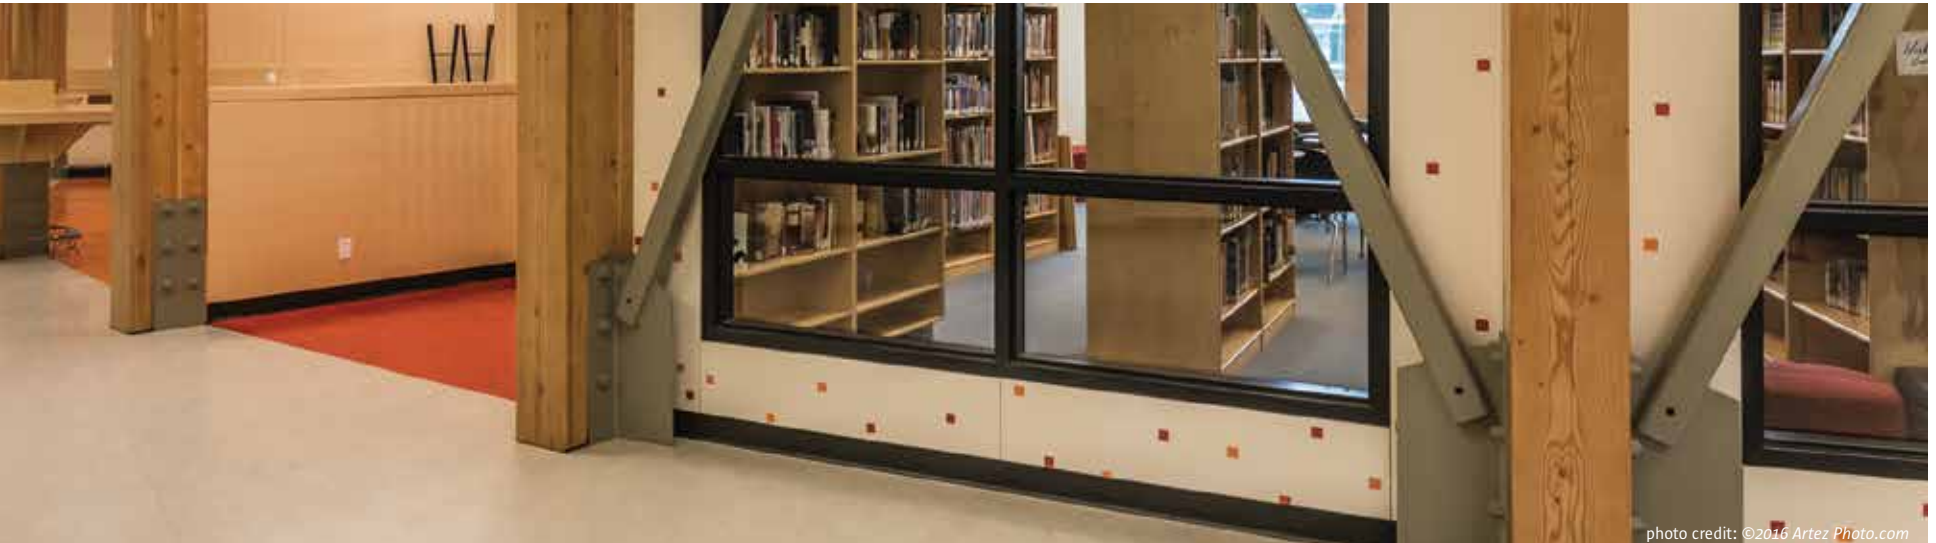
Figure 3.13: Wellington Secondary: New glulam columns fitted with seismic cross-bracing

Throughout the timber structure of Block F, connections are designed to be relatively simple and economical – the majority being exposed steel plates and brackets. Steel brackets are also used to connect the bases of the glulam posts to the existing concrete basement walls (Figure 3.13). The entire wood structure is exposed and supports a profiled acoustic metal deck.

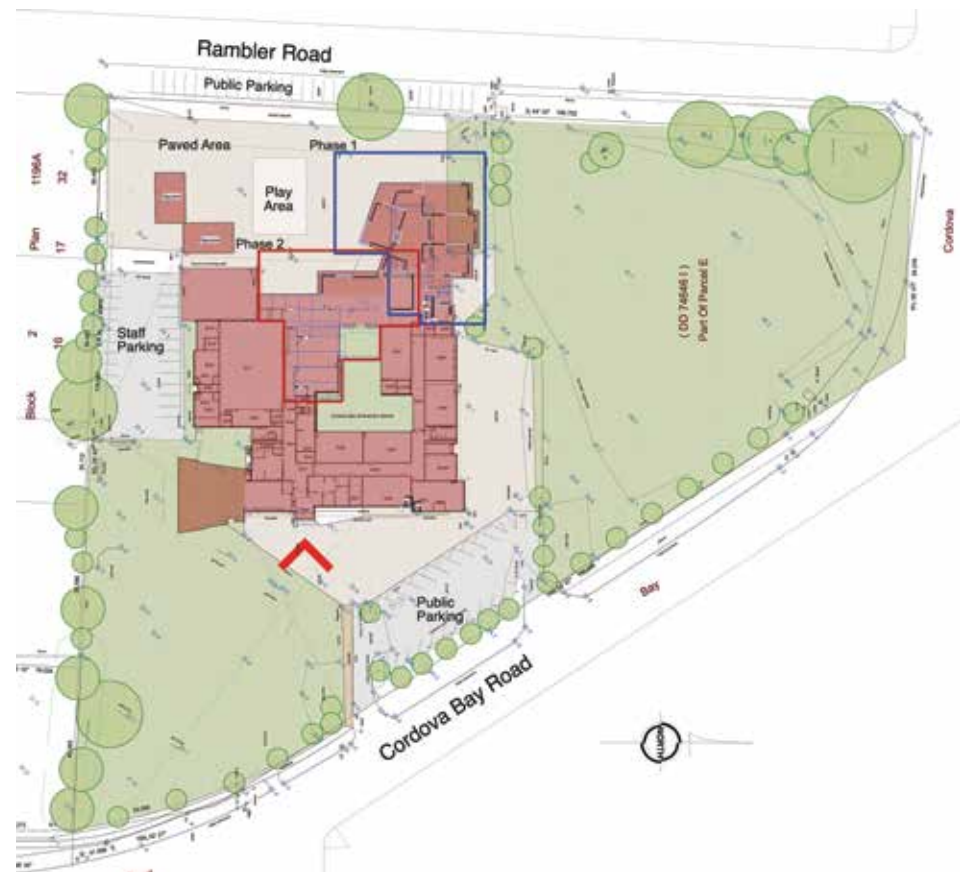
Figure 4.1: Cordova Bay: Site plan

Cordova Bay Elementary School is located in the District of Saanich, on the outskirts of Greater Victoria on the southern tip of Vancouver Island. The original school building was constructed in 1945 using light wood frame and, like Wellington Secondary, has undergone multiple renovations and additions since (Figure 4.1). It now has a capacity of 241 students from kindergarten to Grade 7.

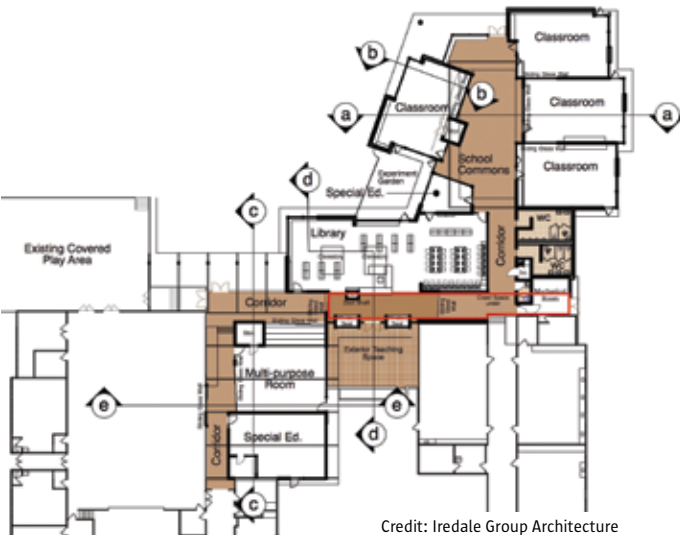
Figure 4.2: Cordova Bay: Plan of new construction

Instead, the design team determined that the demolition and replacement of the existing building could be achieved in two phases, with the library and multipurpose spaces being used as temporary classrooms, eliminating the need for portables. Comparative cost analysis determined that this was a more economical option. In this scenario, the replacement building was approximately 1000 m², with the balance being repurposed from library space to classrooms after the new space was completed (Figure 4.2).

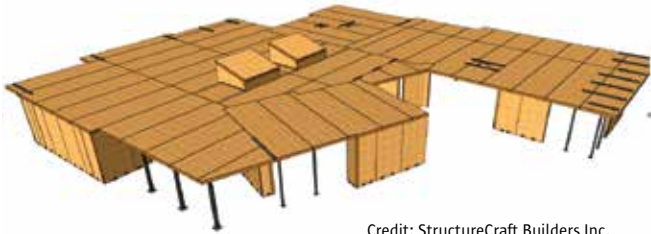
Figure 4.4: Cordova Bay: 3-D model of wood structure

The result is that all of the load-bearing and shear walls are constructed from five-ply CLT, a few non-load-bearing walls are of light wood-frame construction, and the roof is NLT panels made from 2x8 material (Figures 4.4 and 4.5).

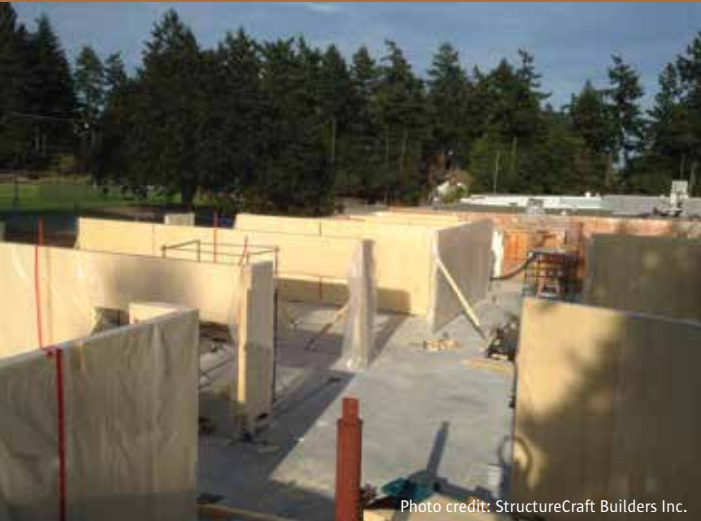
Figure 4.5: Cordova Bay: Installation of CLT wall panels

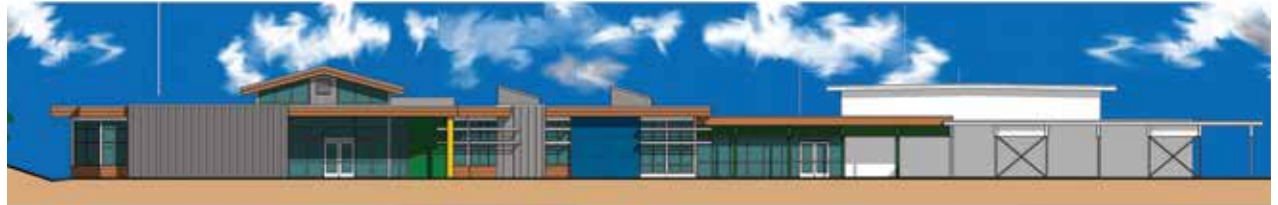
West Elevation

Figure 4.3: Cordova Bay: Elevation of new construction

Having chosen to construct a replacement classroom block, it was proposed that the new structure be built with cross-laminated timber (CLT) wall and roof panels, light wood-frame construction for interior non-load-bearing partitions and cement board and galvanized aluminum cladding to match the 2005 addition (Figure 4.3).

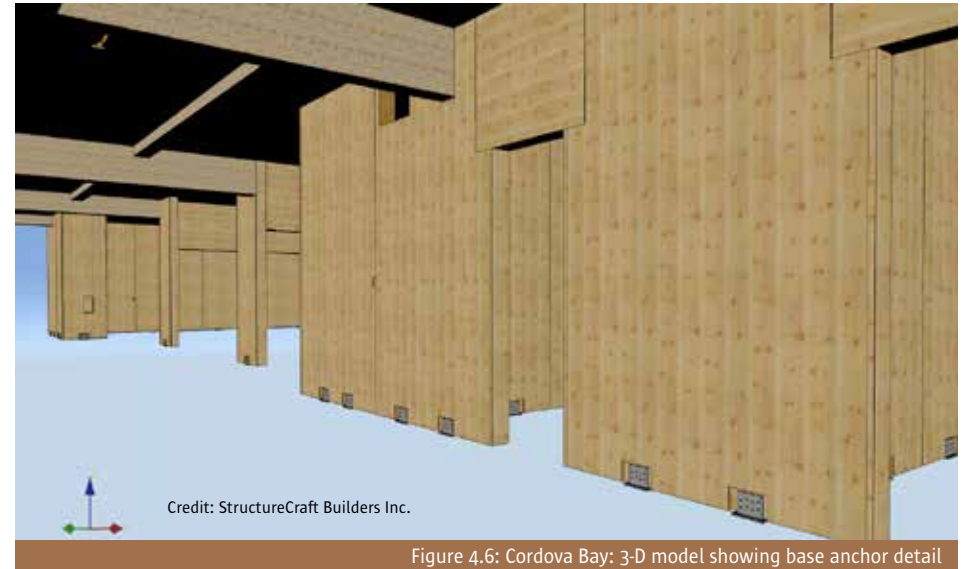
Figure 4.6: Cordova Bay: 3-D model showing base anchor detail

The CLT panels are set vertically, extending from the ground floor slab to the underside of the roof. Base connections are steel plates set into the concrete and recessed into rebates factory-milled into the CLT panels (Figure 4.6). The plates are secured using long, high-strength self-tapping screws, then covered with a wood plug so the connections are hidden and the CLT can be left exposed. The number of anchor plates used for each panel varies according to the lateral load they are required to resist. Some have one anchor plate; others have two.

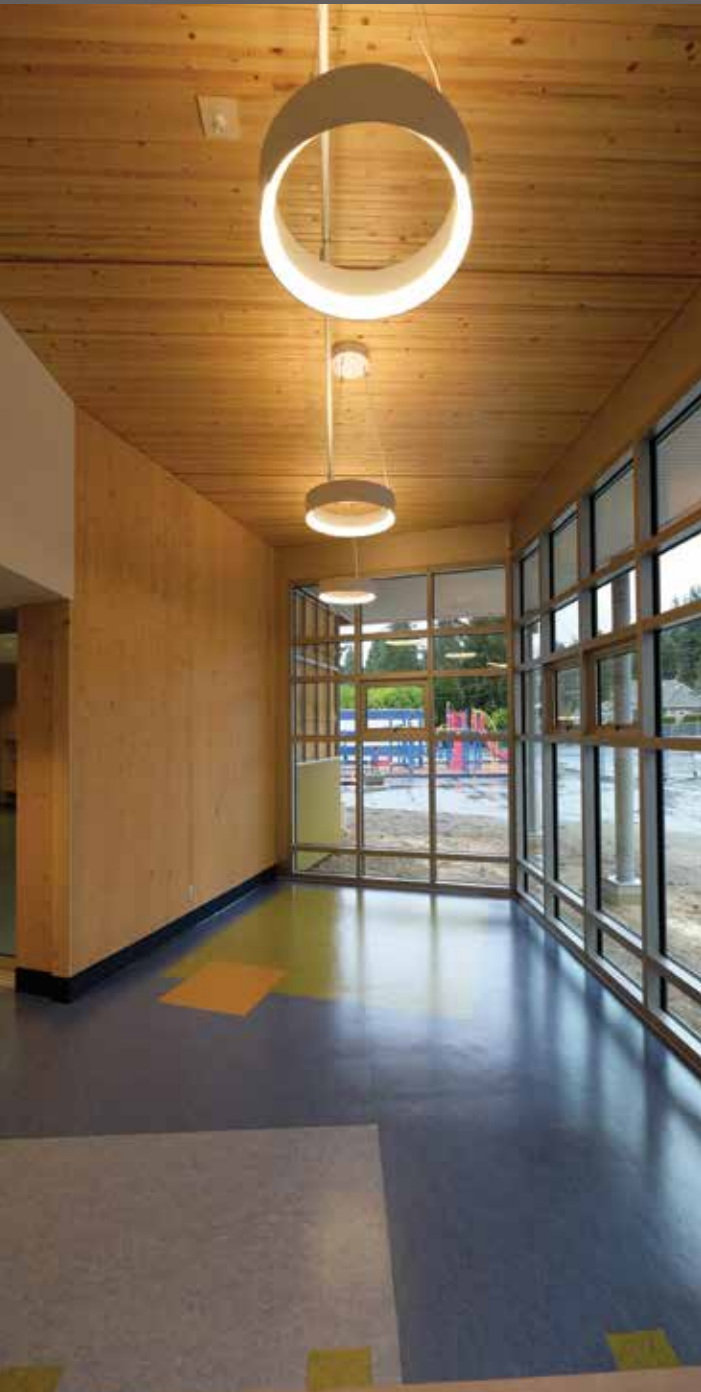
Figure 4.8: Cordova Bay: Interior of lobby showing exposed CLT and NLT panels

The NLT panels bear directly on the CLT walls and are connected to them in a similar way (Figures 4.7 and 4.8). They arrive on site with a plywood diaphragm factory-installed over most of the panel, but held back from the edges. The panels are lifted into place by crane (Figure 4.9) at which point the diaphragm can be completed by installing a final row of plywood sheets that covers the joint between panels.

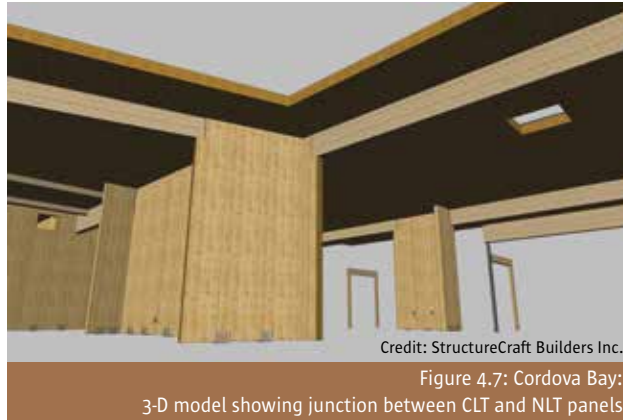
Figure 4.7: Cordova Bay:
3-D model showing junction between CLT and NLT panels

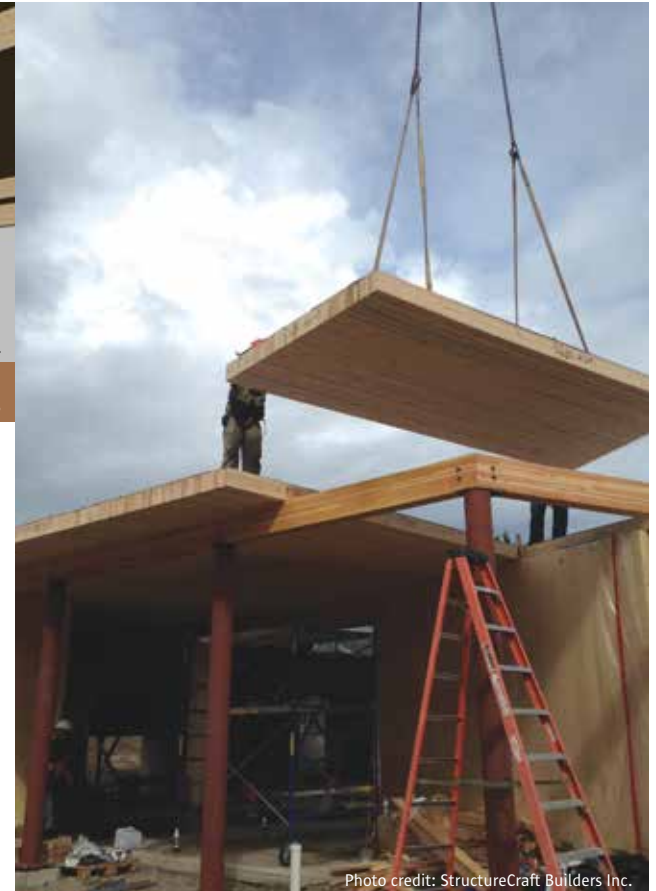
Figure 4.9: Cordova Bay: Installation of NLT roof panels

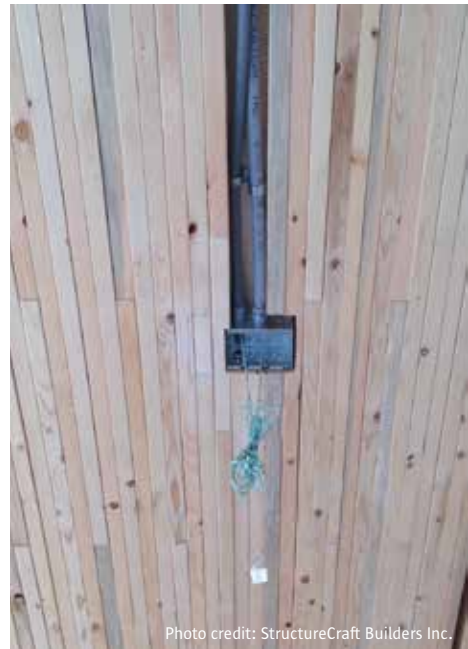
Figure 4.10: Cordova Bay:
Service chase cut in NLT panel

Both the NLT and CLT panels had chases routed into them (as required) in the factory to accommodate conduit and piping for building services. Following installation, cover strips were used to conceal the service runs, creating a clean and uncluttered appearance for the exposed surfaces (Figures 4.10 and 4.11). This detail required a high degree of coordination between StructureCraft Builders Inc. and the members of the design team, for which a virtual 3-D model was essential.

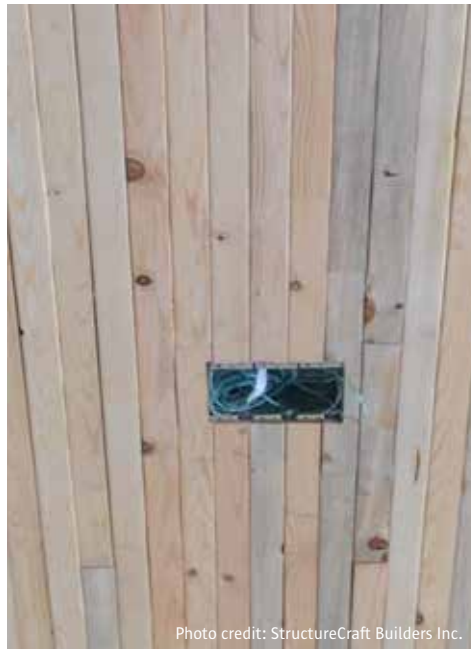
Figure 4.11: Cordova Bay:
Service chase in NLT panel with cover strip installed

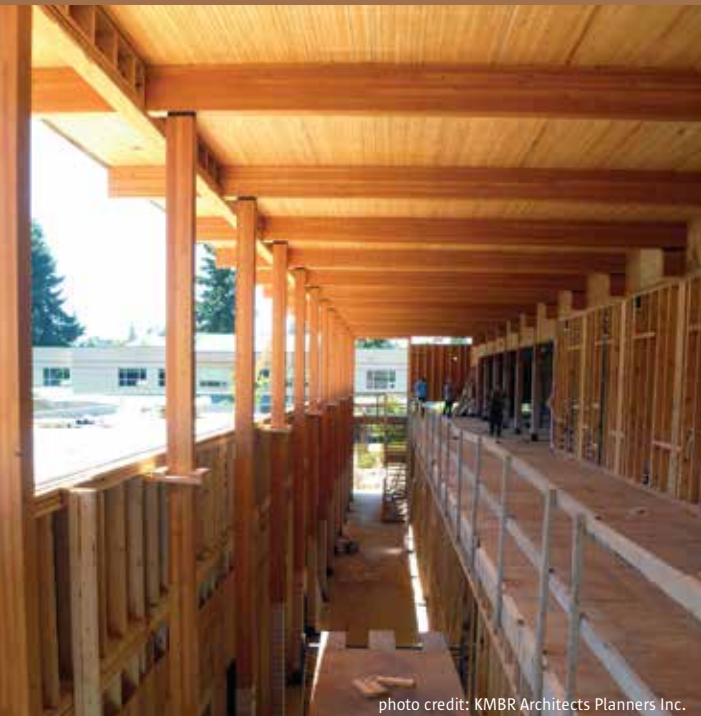
Figure 5.2: Surrey Christian School:
View of post-and-beam structure at the atrium

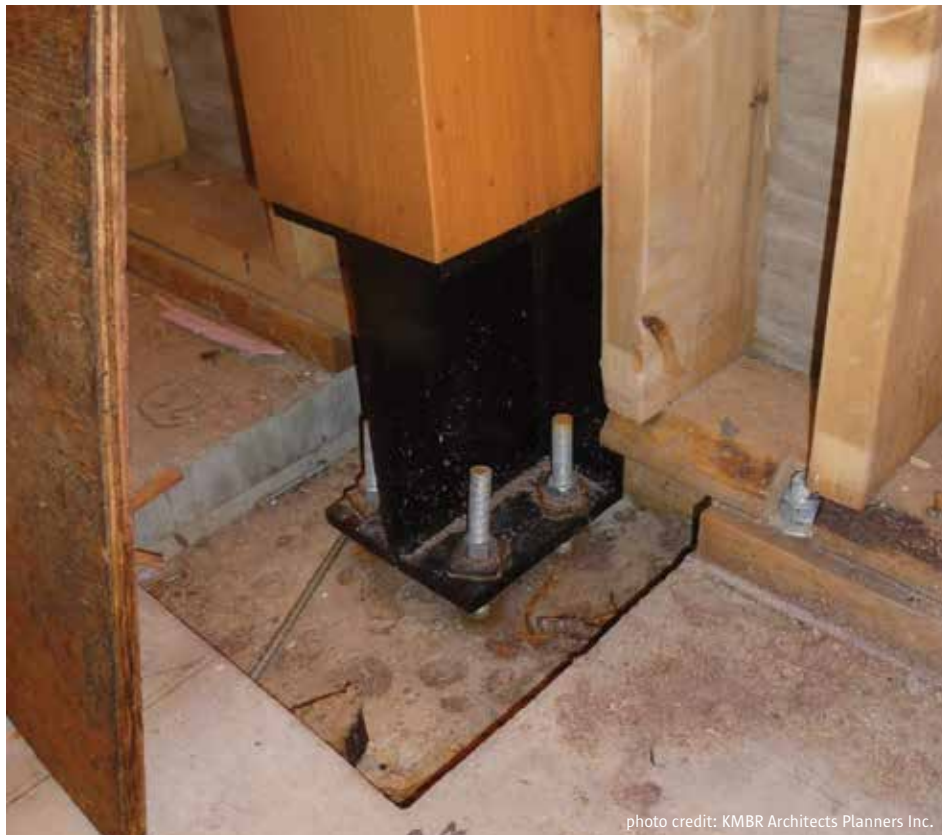
Figure 5.3: Surrey Christian School: Detail of typical column base

The vertical structure consists of glulam posts at 2.7m centres along the length of the building. Each bay consists of four posts, two at the exterior walls and two at the atrium walls. The posts are one storey in height, with the sole exception of those on the south side of the atrium, which rise through two storeys (Figure 5.2). The glulam posts were factory-fitted with custom steel base plates attached using long, high-strength, self-tapping screws installed at opposing angles (Figure 5.3).

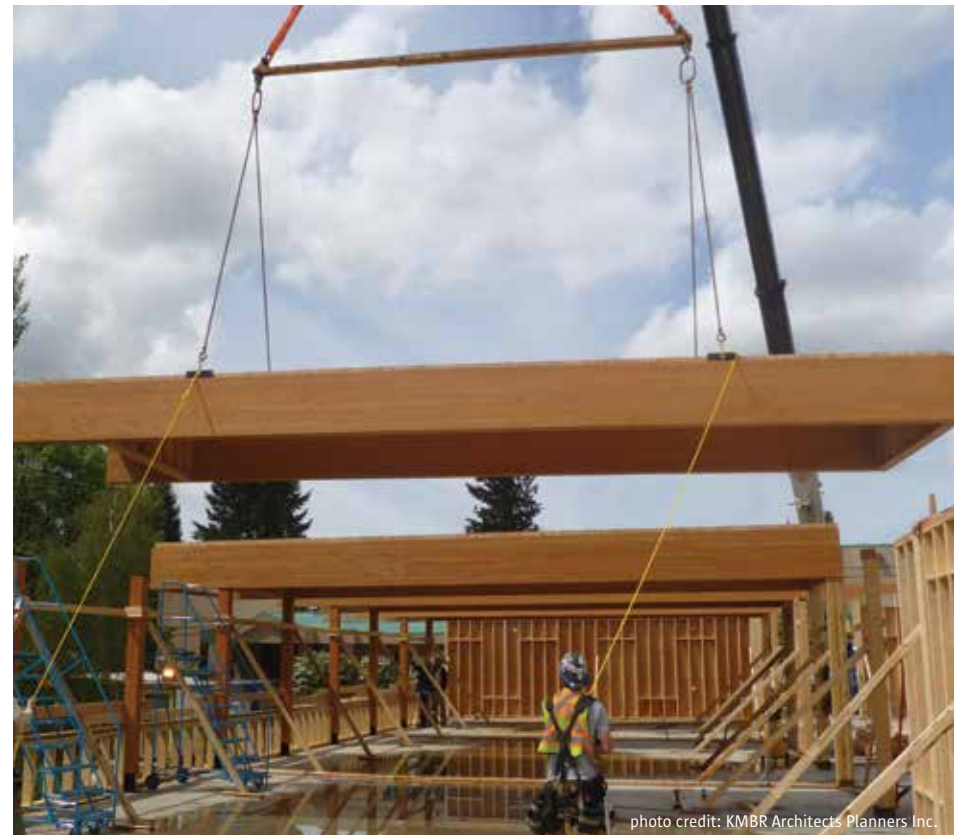
Figure 5.4: Surrey Christian School: Installation of NLT roof panels

The main floor posts were bolted to the concrete slab of the parking structure, and braced longitudinally using light wood-frame infill panels. There are no longitudinal beams in the building. The posts were then ready to receive prefabricated floor and roof panels, 2.7m in width and spanning the full 8.5m depth of the classrooms (Figure 5.4). Each panel has two glulam edge beams connected with light wood-frame header panels at either end and bridged by a deck made up of nail-laminated 2x4 material (Figure 5.5).

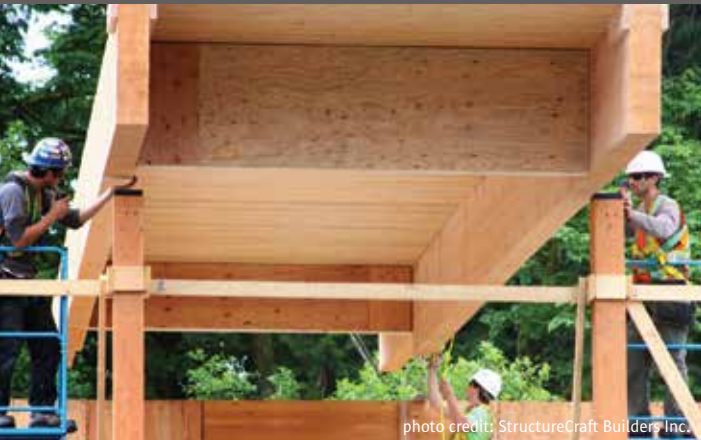
photo credit: StructureCraft Builders Inc.
Figure 5.5: Surrey Christian School: Installation of NLT roof panels

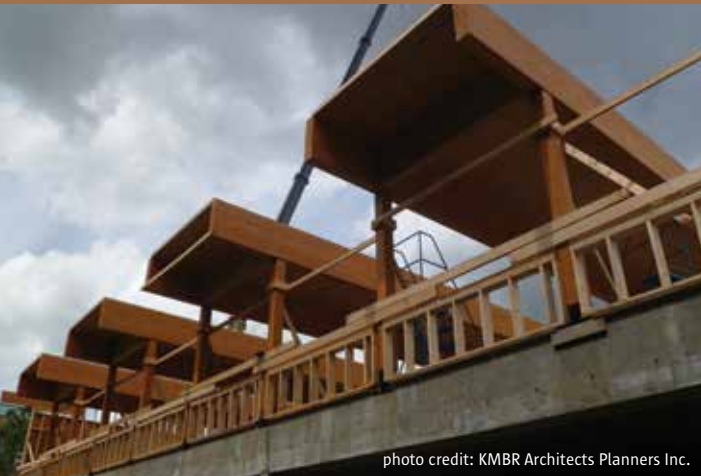
Figure 5.6: Surrey Christian School: Primary roof panels installed in alternate bays leaving gaps for infill panels

These panels were installed in alternate bays along the length of the building (Figure 5.6), leaving the spaces between them to be filled with a second panel type that consisted only of 2x4 nail-laminated timbers (NLT). Because they were not stiffened by edge beams, these panels had to be lifted into place with great care, using spreader bars and multiple lifting points. The edge beams of the main panels rest directly on top of the posts and are connected to them with a similar detail to that used at the base (Figure 5.7).

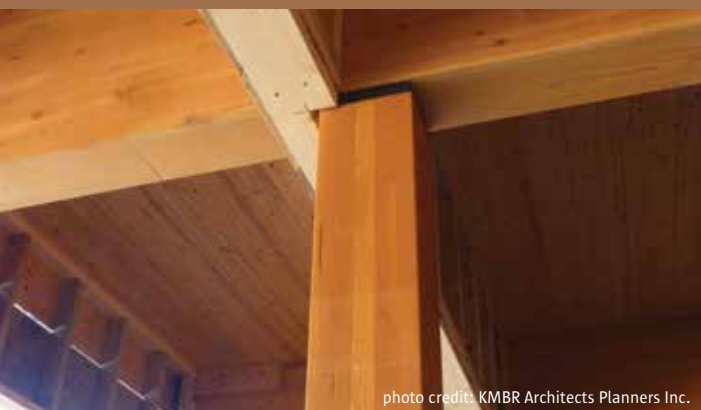
Figure 5.7: Surrey Christian School: Detail of roof beam-to-column connection

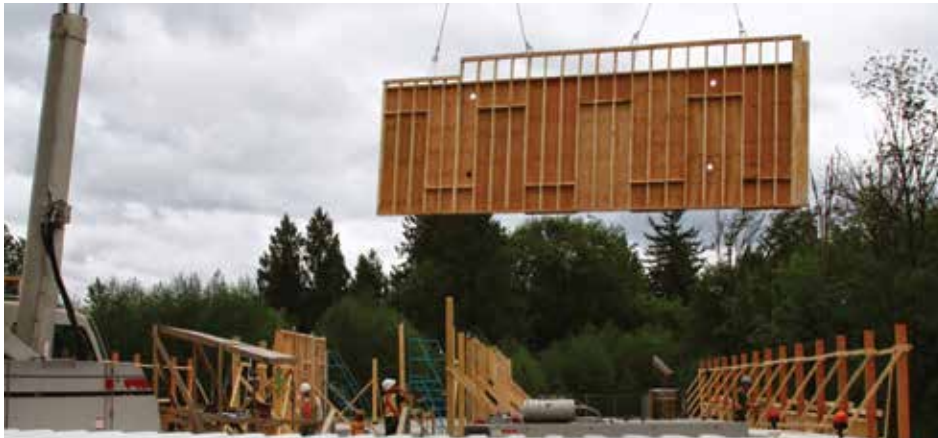
Figure 5.8: Surrey Christian School: Installation of prefabricated light wood-frame shear walls

Once all the main floor panels were installed, plywood sheathing was laid by the general contractor to create a horizontal diaphragm. The plywood was reclaimed from the formwork used for the parking garage. In the vertical plane, lateral stability is achieved by plywood-sheathed light wood-frame walls running north-south at either end of the building, and east-west along the length of the corridor between door openings. These shear walls were also prefabricated off site by StructureCraft Builders Inc. and installed using a crane (Figure 5.8). The lateral system was designed to resist all the required seismic loads, enabling the exterior walls of the classrooms to be fully glazed (Figure 5.9).

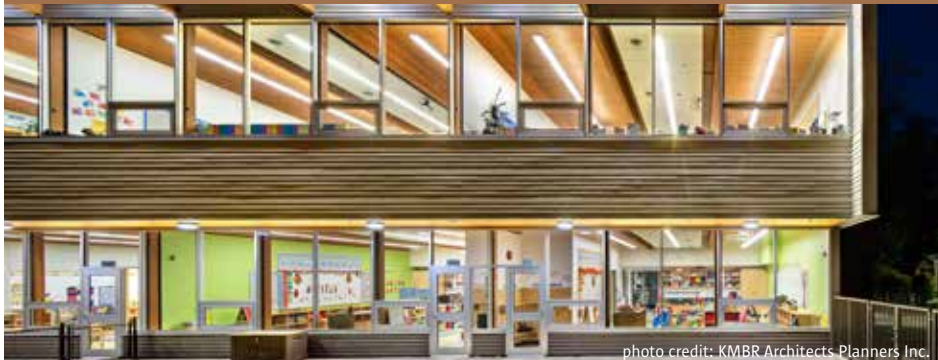
Figure 5.9: Surrey Christian School:

The placement of shear walls enables the exterior walls of the classrooms to be fully glazed

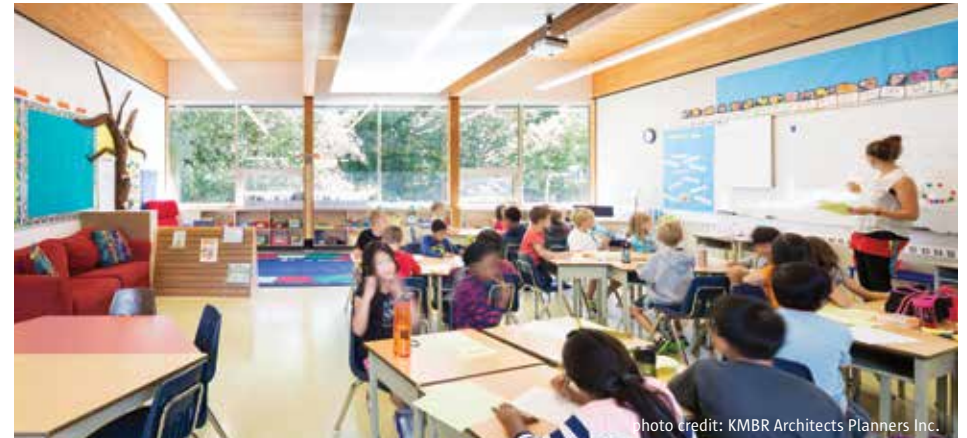
Figure 5.10: Surrey Christian School: A suspended ceiling conceals services in the central bay of each classroom, enabling the NLT panels on either side to remain exposed

Within the building, systems integration was neatly achieved by concentrating mechanical ductwork in the central bay of each classroom and covering it with a suspended acoustic ceiling. This enabled the underside of the other floor and roof panels to be left exposed (Figure 5.10).

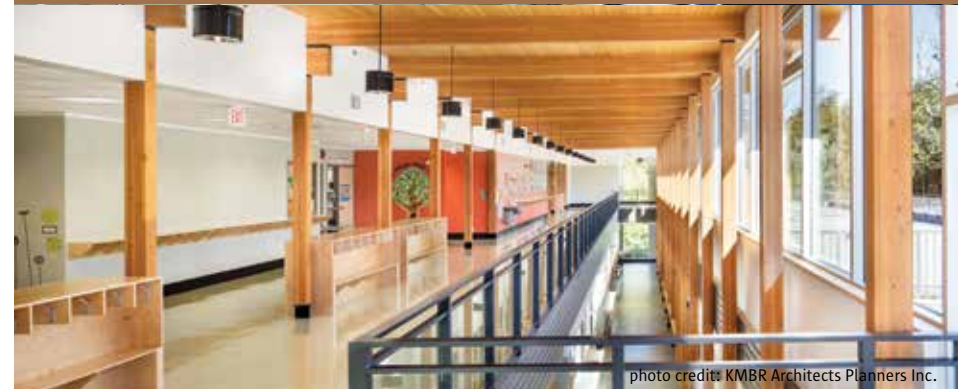
Figure 5.11: Surrey Christian School: Exposed wood structure in the atrium

With the wood soffits of most roof panels and the glulam structure in the atrium being left exposed, the school has a warm and welcoming atmosphere that has exceeded the client's expectations and delighted students and teachers alike (Figure 5.11).
