Taller and Larger Wood Buildings:

Potential Impacts of Wetting on Performance of Mass Timber Buildings

Date: December 2015

**PROJECT NO. 301010143:
Taller and Larger Wood Buildings:**

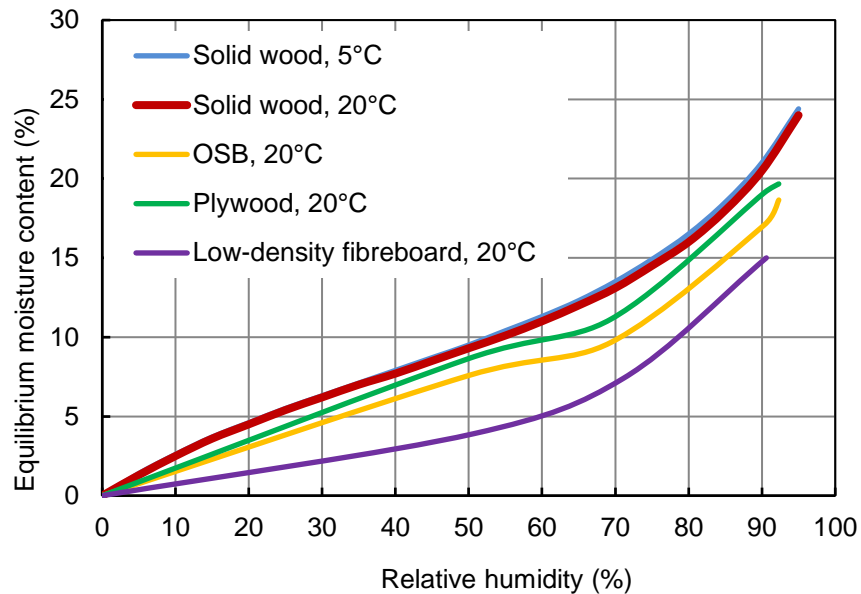
Figure 1 Representative isothermal sorption curves: equilibrium moisture content of solid wood and wood-based composites at various relative humidity levels (data sources: FPL 2010; Kumaran 2002)

Under constant humidity and temperature conditions, the wood will achieve an EMC when it no longer gains or loses moisture (i.e., when there is a balance between desorption and adsorption). Because adsorption and desorption are much slower than typical fluctuations in environmental RH, in practice wood never reaches an EMC. However, the MC will normally fluctuate over a small range within a certain environment, and this stable MC can be considered an EMC in practice. Figure 1 shows the average EMC, i.e., isothermal sorption curves of solid softwood (e.g., S-P-F, Douglas fir) with changes in RH at two levels of temperature (with data based on FPL 2010). The EMC of wood is primarily determined by the RH of the environment. Other factors including temperature (under a given RH), wood species, and drying history all have small effects. Regarding species, the chemical compositions including the cell wall components (i.e., cellulose, hemicellulose, and lignin) as well as extractives have effect. For example, some extractives in western red cedar, i.e., the polar extractives including plicatic acid, were found to contribute to the low EMC and good durability of the wood (Stirling and Morris 2006). On average wood will reach a MC around 11% when the RH is about 60% and will equilibrate around 8.5% when the RH is about 45%, at a temperature of about 20°C. Figure 1 also includes the EMC of OSB, plywood, and a type of low-density fibreboard (with data based on Kumaran 2002). Wood-based composite products usually have an EMC lower than that of the parent wood material due to the added chemicals (e.g., adhesive, wax) and the high temperature treatment during manufacture (Onysko *et al.* 2010). Related to this sorption behavior, Appendix II provides typical MC ranges under outdoor sheltered or indoor environmental conditions in different climates in Canada (from CWC 2005, Table 5.3). A German study monitoring 21 non-residential timber buildings including indoor swimming pools, ice arenas, gymnasiums, agricultural, and warehouses showed that the average MC of timbers (mostly glulam) ranged from 4.4% to 17.1% (Winter *et al.* 2014).

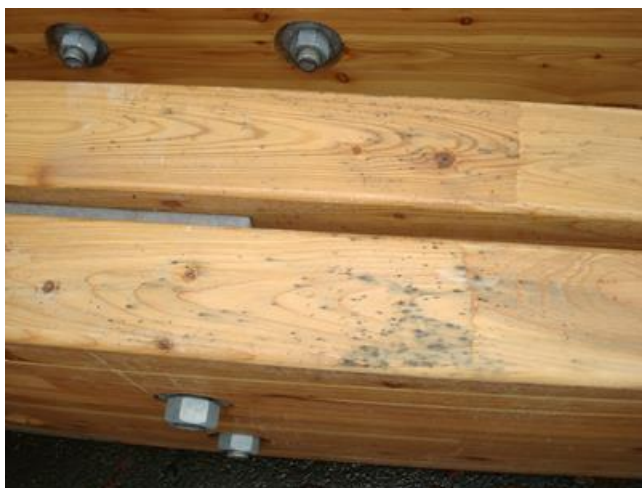
Figure 2 Iron staining on glulam resulting from on-site wetting and contamination with iron particles

Mold growth and fungal staining can occur on wood members when there are suitable conditions (Morris 1998; FPL 2010, Chapter 14). These fungi live on non-structural components of wood, such as starches in cell lumen, and therefore appear on sapwood more often. They primarily affect the appearance rather than the strength of wood. **These fungi generally require a high RH, such as higher than 90%, and warm conditions to grow fast.** Research shows that mold needs a minimum surface RH (sometimes called “water activity”) around 80% to grow on wood at a temperature of 20-25°C; under such marginal conditions, it could take months or longer to initiate on non-resistant wood materials, which could be detected probably only by microscopy (Viitanen and Paajanen 1988; Nielsen *et al.* 2004; Yang 2005). Compared with the heartwood of most species, the sapwood as well as wood-based composites, such as fibreboard and OSB, tends to be more susceptible to mold growth; fluctuating RH conditions, such as between 95% and 65%, generally retard the growth compared to the higher RH conditions (Yang 2005). For buildings, incidents of mold growth or other types of fungal staining occurring during construction or in service are more often associated with wetting caused by liquid water sources, such as rain penetration, ground source moisture, vapour condensation (e.g., resulting from air exfiltration), and pipe leakage. Aside from fungal staining, wood may also develop chemical staining. For example, iron stain is caused by presence of iron in combination with moisture (Figure 2). For appearance products and exposed mass timbers, staining often requires costly remediation efforts to remove the affected surface areas and to refinish. Attention should be paid to preventing wetting incidents and improving the drying ability, e.g., through improved ventilation.

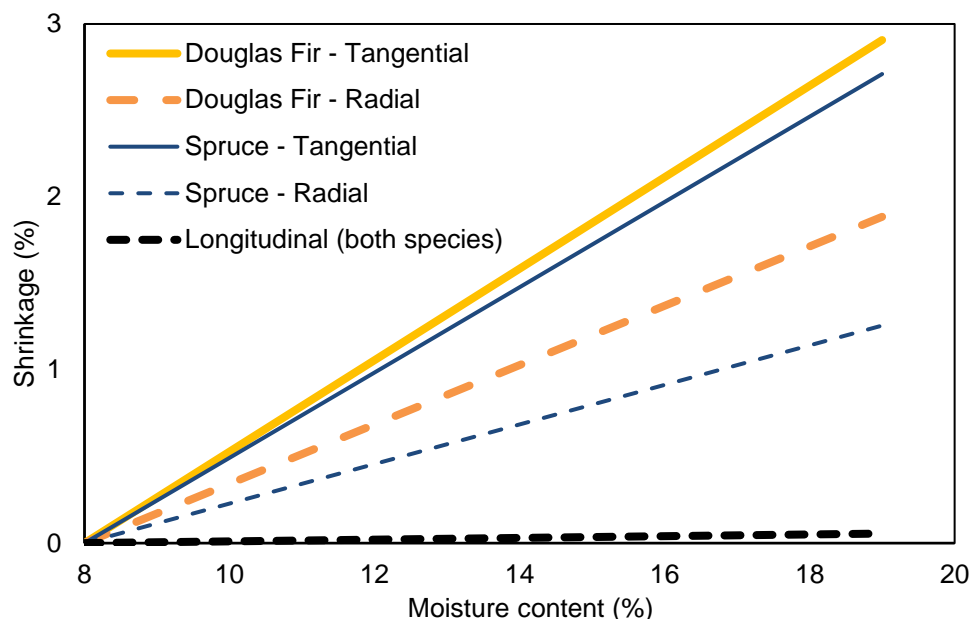
Figure 3 Shrinkage of two wood species in major grain orientations

For predicting differential shrinkage in design, detailed information is provided in Chapter 5 of the Mid-rise Wood-Frame Construction Handbook (Ni and Popovski 2015). Wood is an anisotropic material in terms of shrinkage and swelling. It shrinks or swells considerably more across the grain than in the longitudinal direction, with the amount almost in direct proportion to the moisture change. For example, the average shrinkage in the tangential direction (in the direction of the annual growth rings) of spruce from a MC of 19% to 8% is about 2.7% (of the dimension) and the average shrinkage in the radial direction (in the direction across the growth rings) is about 1.3%. Over the same MC range, the average shrinkage of Douglas fir in the tangential direction is about 2.9% and that in the radial direction is about 1.9% (Figure 3, data based on Jessome (1977)). It is recommended to use an average shrinkage coefficient of 0.25% per 1% change in MC for cross sections of softwood dimensional lumber or sawn timbers (Ni and Popovski 2015). The shrinkage amount in the longitudinal direction is typically very small and can be neglected in design in most cases. Differential shrinkage also occurs between sawn wood and engineered wood products. Minimal shrinkage can be expected for an engineered wood product if the MC during manufacturing is very close to the EMC in the service environment. It was found from field monitoring that glulam columns were extremely dimensionally stable in the longitudinal direction, without any horizontal wood members in the load path; CLT walls were also very stable along the height (Munoz *et al.* 2012; Wang 2015b). A small amount of swelling may occur if the MC of wood increases resulting from incidental wetting or high humidity construction conditions (Wang and Ni 2014). However, there is very limited data available about MC adaptation or shrinkage coefficients of most engineered wood composites, such as PSL, LSL, LVL, OSL, and in-plane CLT. These products merit testing given the fact that more and more engineered wood products are used, in mid-rise and taller buildings in particular.

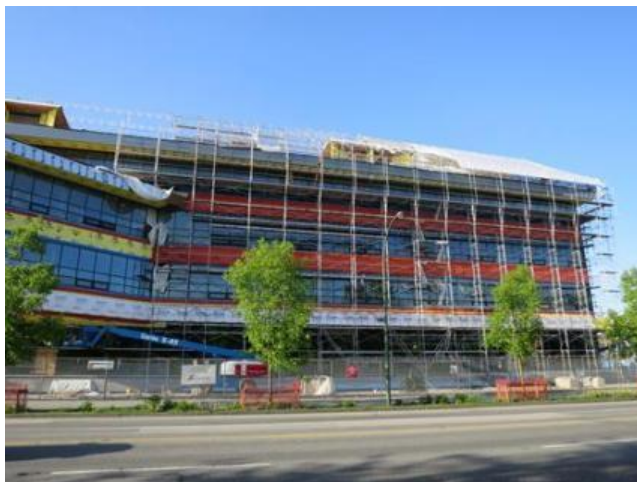
Figure 4 Using a tent to protect roof construction in a recent Vancouver project

- Pre-installing protective membrane on members or assemblies
- Using a temporary roof to protect partial or the entire construction (see examples in Figures 4 and 5)

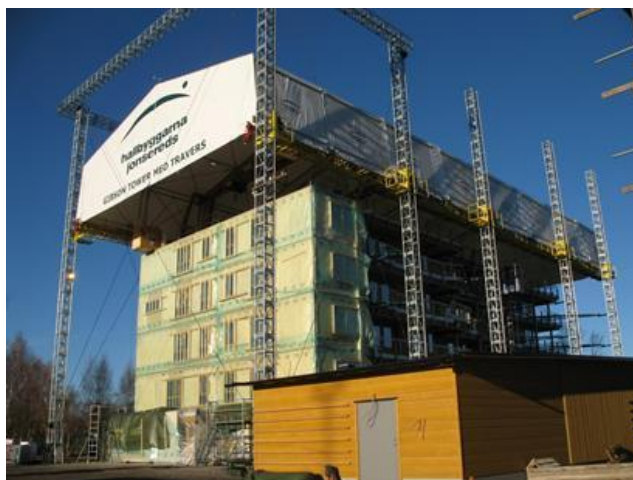
Figure 5 Using a movable tent to protect the entire construction in Sweden

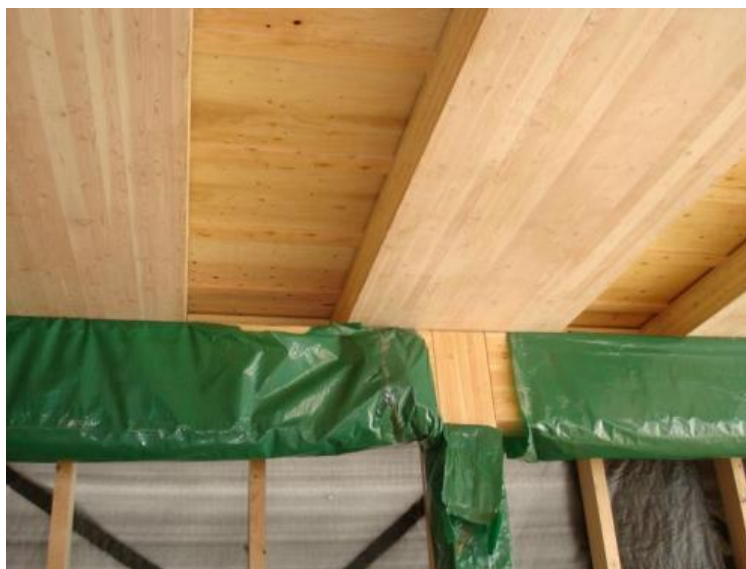
Figure 6 Interior air space built in the mass timber roof of the Wood Design and Innovation Centre in Prince George accelerating drying and enabling leak detection
