# Monotonic Quasi-static Testing of CLT Connections (REVISED – Version 3)

**Date:** June 30, 2015

**PROJECT NO:** 301009106 Task 12.2  
**Monotonic Quasi-static Testing of CLT Connections (REVISED – Version 3)**

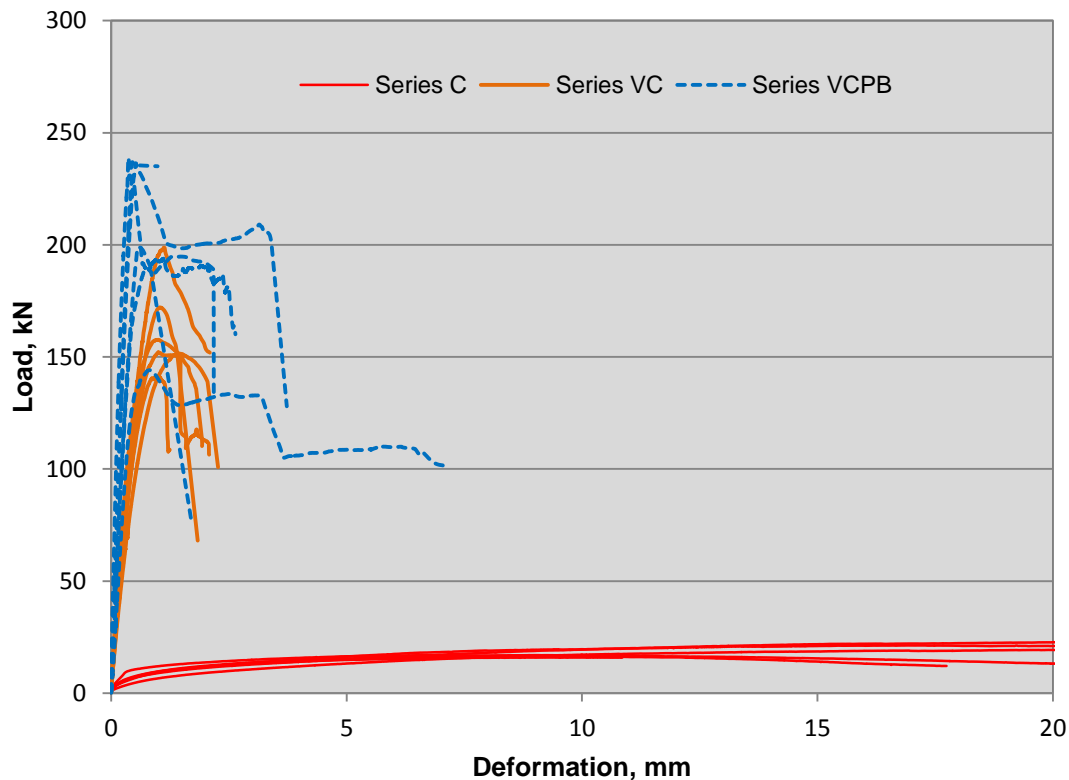
Figure 6. Load-deformation curves for all specimens classed by Series

In order to facilitate the assessment of the relative performance of the three (3) assemblies, Figure 6 presents load-deformation curves for every specimen tested in this study superimposed into one graph.

It may be observed that Series VCPB (wood screws and Purbond) had the highest stiffness (**K**) and ultimate loading capacity (**P<sub>ult</sub>**) out of the three (3) assemblies.

Series C (common nails and no adhesive) had a significantly lower **P<sub>ult</sub>** and **K**; however it portrayed a much more ductile behavior.

Series VC (wood screws and PL Premium) had a slightly lower **P<sub>ult</sub>** and **K**, however it had a significantly smaller variation (smaller CV%) than Series VCPB.

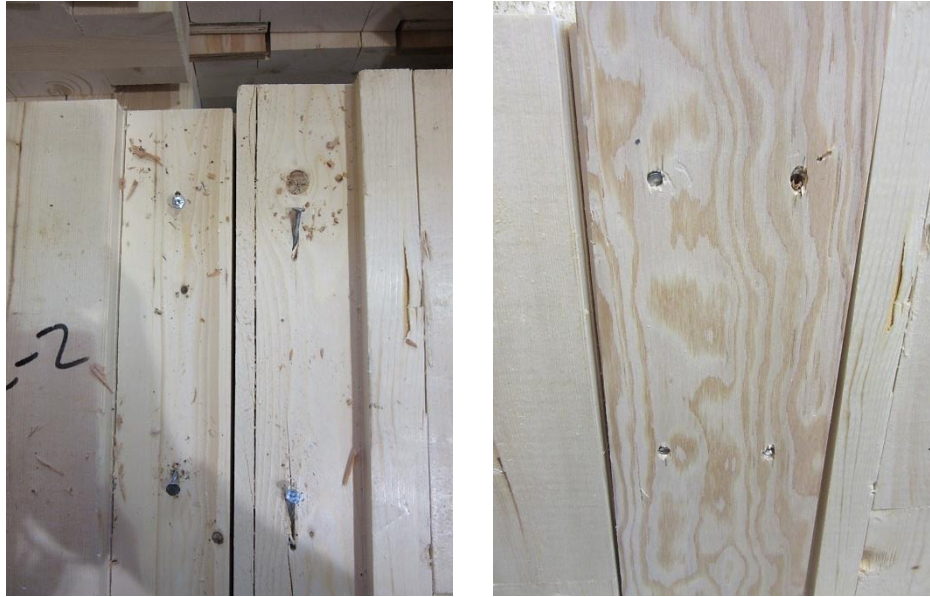
**Figure 7. Typical mode of failure for specimens of Series C**

The dominant failure mode of specimens from Series C was nail bending facilitated by pull through of the nail head in the plywood panel and splitting of the CLT fiber as shown in Figure 7.

- The failure mode for Assembly C was generally bending of the nails facilitated by pull through at the plywood panels;
- The failure mode for Assemblies VC and VCPB was generally a slip at the glue line of the first lamination of the plywood followed by shear failure of the screws.

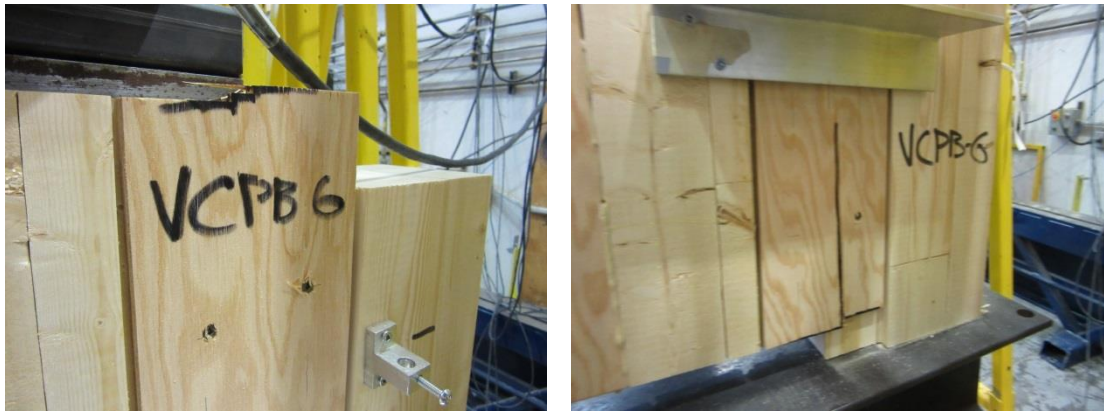
**Figure 9. Shear through the plywood thickness observed for specimen VCPB 6**

The dominant mode of failure for specimens of Series VCPB was failure of the glue line at the first lamination of the plywood panel very similar to what was observed for Series VC. Interestingly, Specimen VCPB6 portrayed a shear failure along the entire thickness of one of the plywood panels as

shown in Figure 9. Photographs of the failure modes for every specimen tested are provided in the Appendix I.
