## ***Treated Finger-Jointed Lumber***

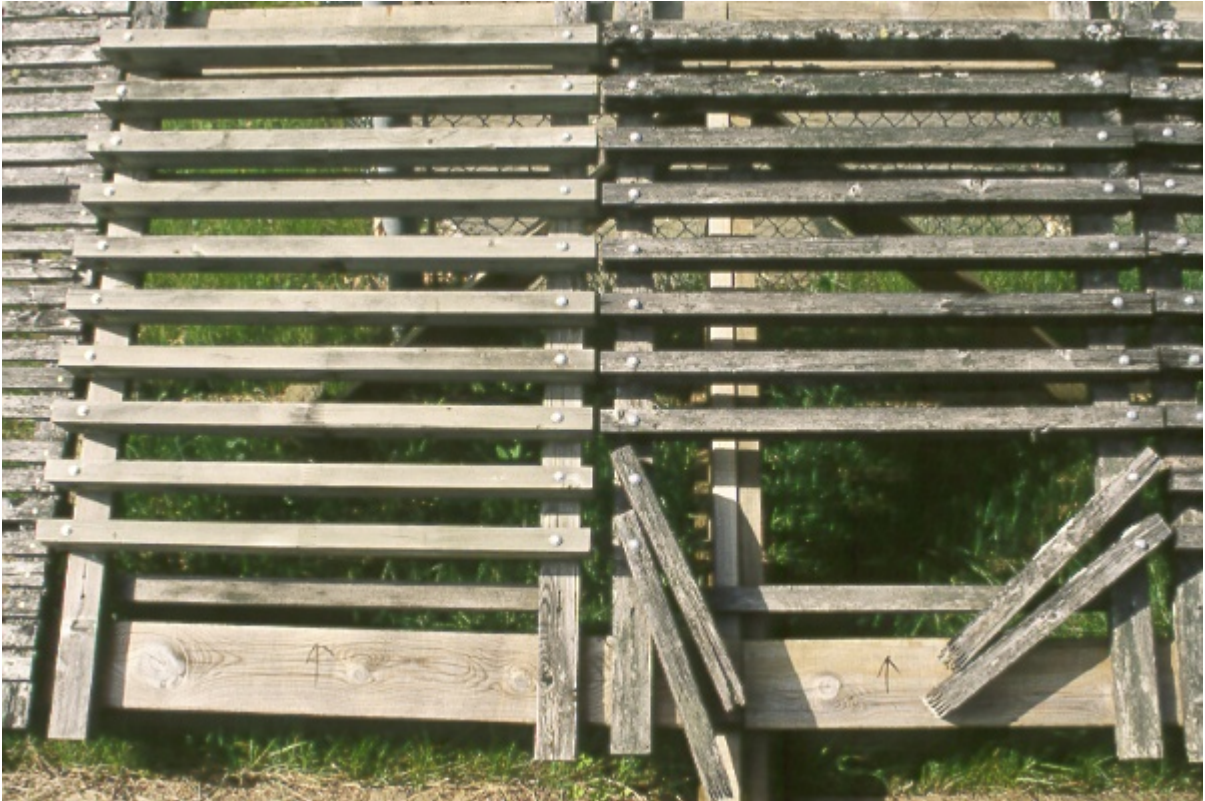
CCA-treated and untreated finger-jointed lumber showing decay at the joints. This is a relatively low decay hazard because the test materials are well-spaced and the test unit does not trap water.

**Condition of Untreated Samples:** 73% of boards severely decayed or failed after 25 yrs (first failures at 12 years)

**Condition of Treated Samples:** 100% of boards serviceable after 25 yrs
